A SURVEY OF WAREHOUSES IN ULVERSTON, CUMBRIA

During March 2005 it was decided to undertake a rapid survey of all of the identifiable warehouses and warehouse-like buildings in Ulverston. The aim of the survey was to identify how many of this type of building exist, what condition they are in, what uses they are put to and their distribution within the town. A gazetteer of all of the sites was compiled and photographs were taken. A brief amount of analysis was carried out of the results and a short historical background prepared in order to put them into context.

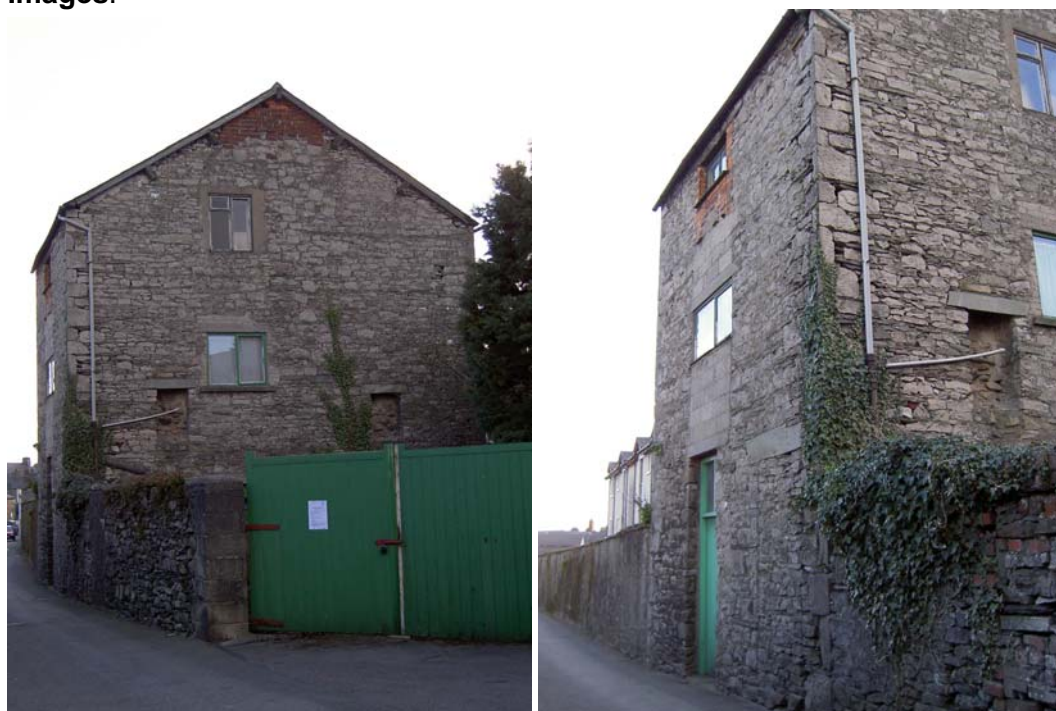
Site Number: 04**Address:** Back Lane**Current use:** Empty**Preservation:** 3**Condition:** Poor**Statutory designation:** Within Conservation Area**Architectural quality (defined by CACA):** Adverse

North-west external elevation (left) and north-east (front) external elevation (right)

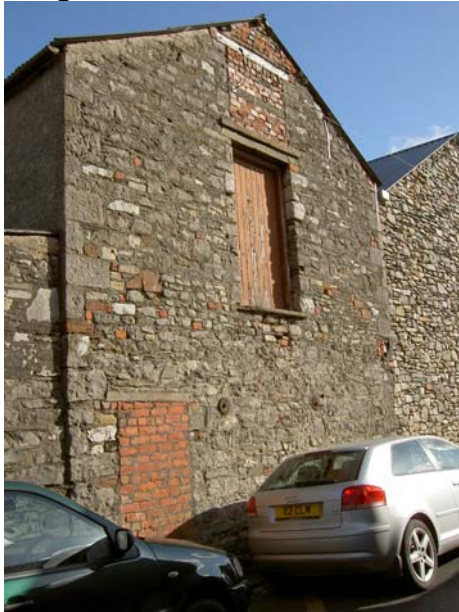
Site Number: 05**Address:** Back Lane**Current use:** Storage**Preservation:** 2**Condition:** Poor**Statutory designation:** Within Conservation Area**Architectural quality (defined by CACA):** Adverse

South external elevation

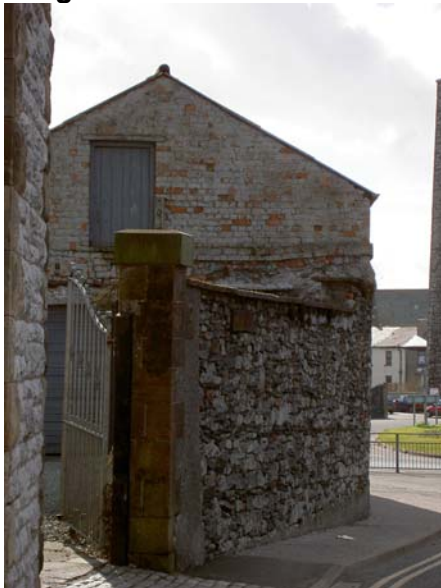
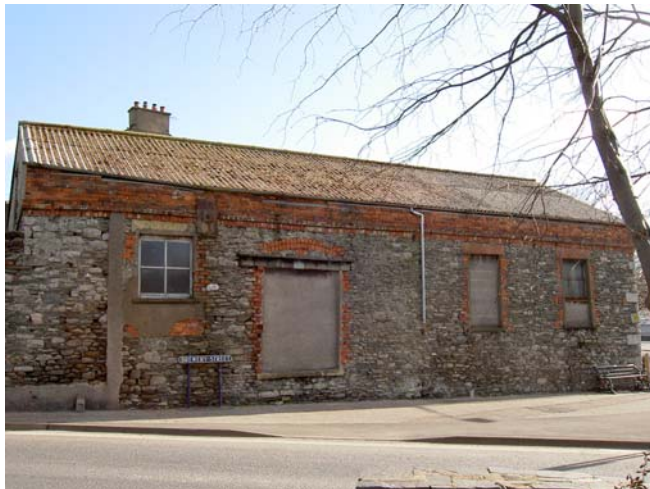
Site Number: 06**Address:** Brewery Street**Current use:** Unknown**Preservation:** 3**Condition:** Poor**Statutory designation:** Within Conservation Area**Architectural quality (defined by CACA):** Adverse

North-west external elevation (left) and south-west elevation (right)

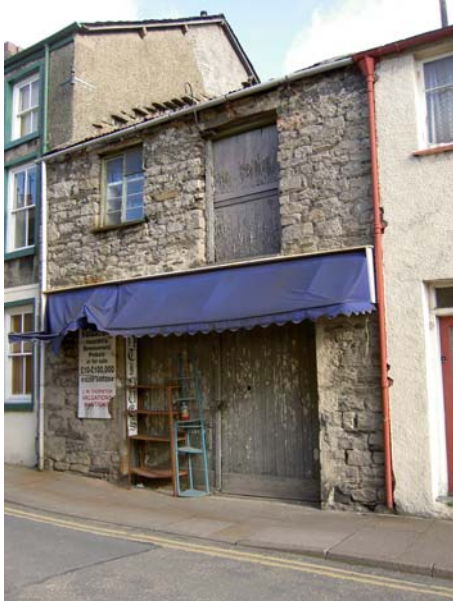
Site Number: 08**Address:** Market Street**Current use:** Storage**Preservation:** 2**Condition:** Poor**Statutory designation:** Within Conservation Area**Architectural quality (defined by CACA):** Neutral

South-west (front) elevation

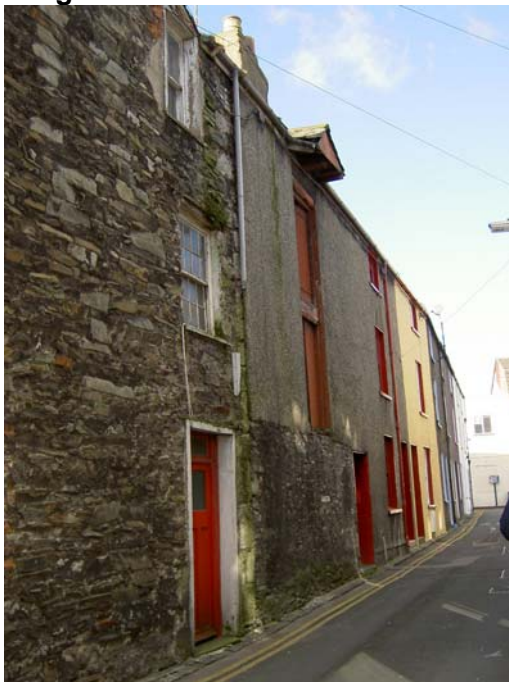
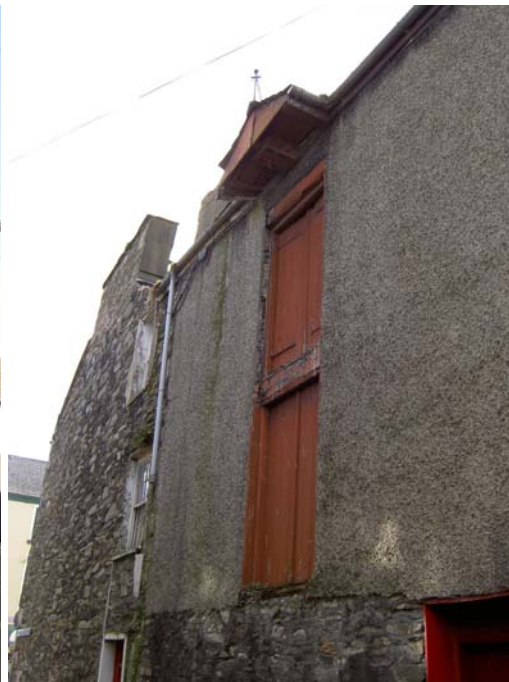
Site Number: 09**Address:** Little Union Street**Current use:** Unknown**Preservation:** 1**Condition:** Poor**Statutory designation:** Within Conservation Area**Architectural quality (defined by CACA):** Neutral

Description: Three storeys, first and second floors rendered, ground floor roughly coursed slate. Within a row of houses, but may form part of building to east. Loading doorways and doors survive in good condition on first and second floors of north elevation and timber gabled canopy originally covering hoist also intact. The building to the east recently had a planning application for conversion to housing.

North external elevation

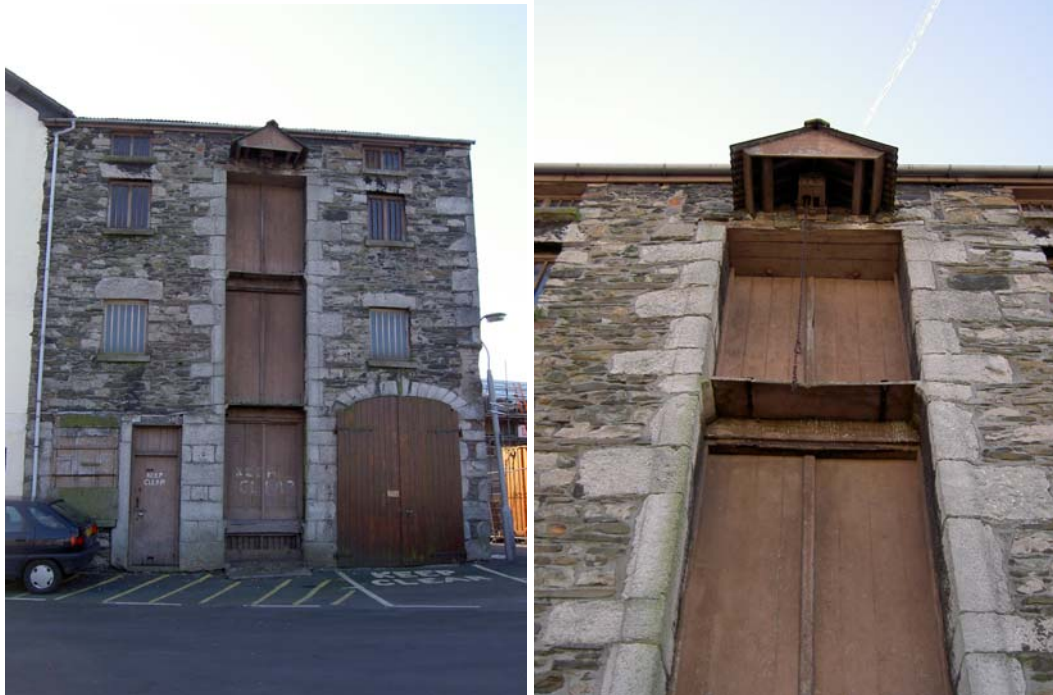
Site Number: 11**Address:** Buxton Place**Current use:** Unknown**Preservation:** 1**Condition:** Poor**Statutory designation:** Within Conservation Area; Listed**Architectural quality (defined by CACA):** Listed

North (front) external elevation

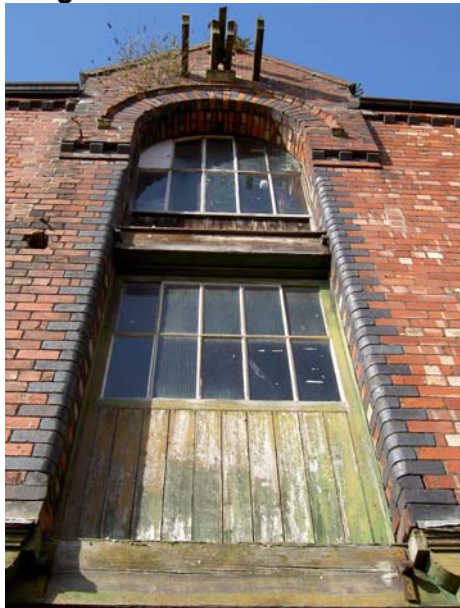
Description: Three storey, brick. There are central loading doorways on each floor in the front (east) elevation beneath a round arch and a blind dormer, with the remains of the hoist, flanked by a pair of windows. At ground floor the sill of the first floor loading doorway is supported by a timber beam with scrolled corbels and a pair of elaborate cast iron brackets. There is evidence for subsidence cracks below several of the windows on the south side. The end wall of a smaller building, including its extant chimney, are visible against the south elevation. It is currently for sale and formed the back of a shop (Fletcher and Robinson) on Queen Street.

East (front) external elevation

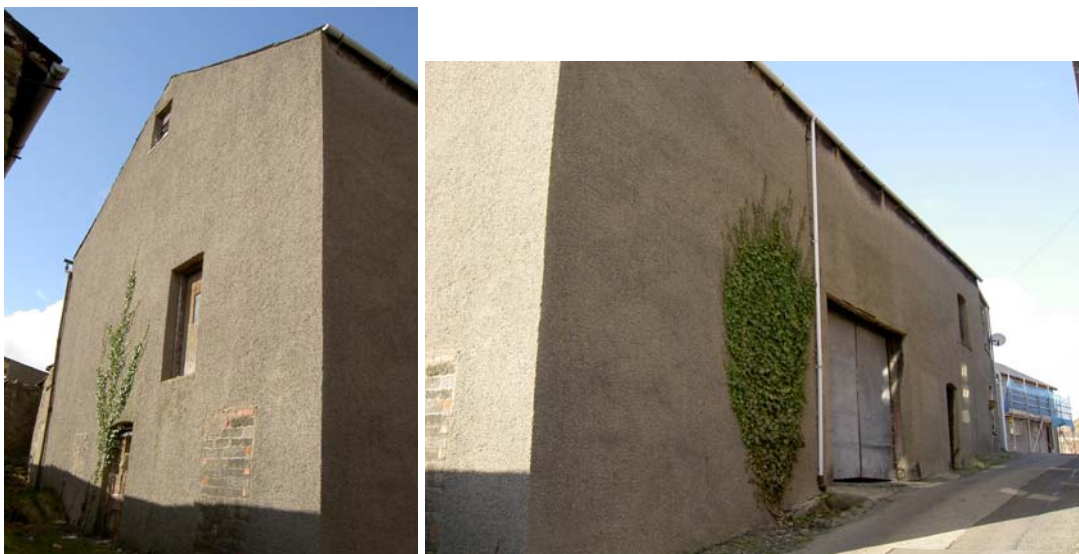
Site Number: 33**Address:** Back Lane**Current use:** Storage**Preservation:** 3**Condition:** Poor**Statutory designation:** Conservation Area**Architectural quality (defined by CACA):** Neutral

South elevation (left) and east elevation (right)

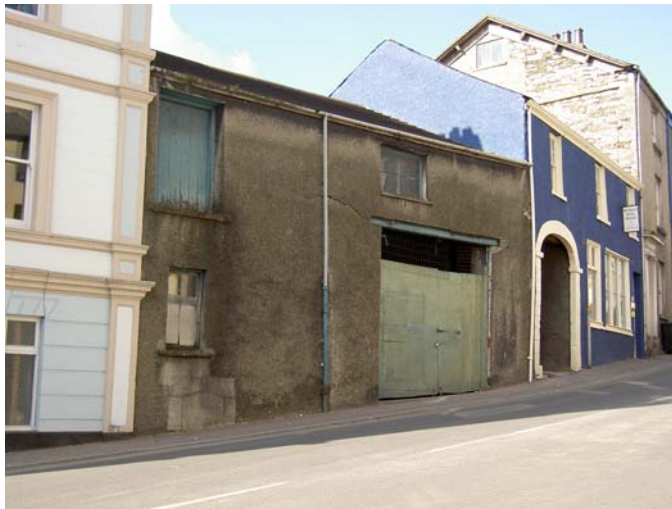
East (front) external elevation

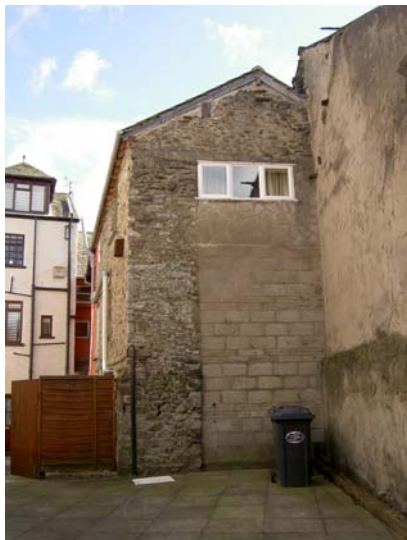
Site Number: 41**Address:** Leather Lane**Current use:** Domestic**Preservation:** 4**Condition:** Poor**Statutory designation:** Conservation Area**Architectural quality (defined by CACA):** Not examined

North-west external elevation

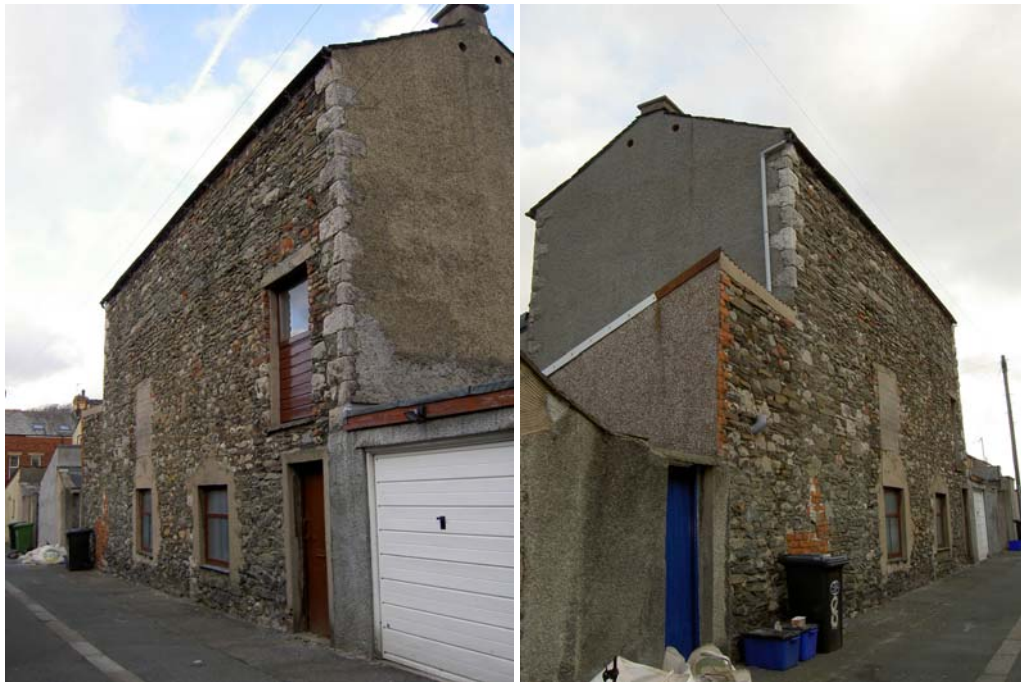
Site Number: 49**Address:** Alley between Casson Street and Clarence Street/Casson Street**Current use:** Unknown**Preservation:** 3**Condition:** Poor**Statutory designation:** None**Architectural quality (defined by CACA):** Adverse

Rear (west) external elevation

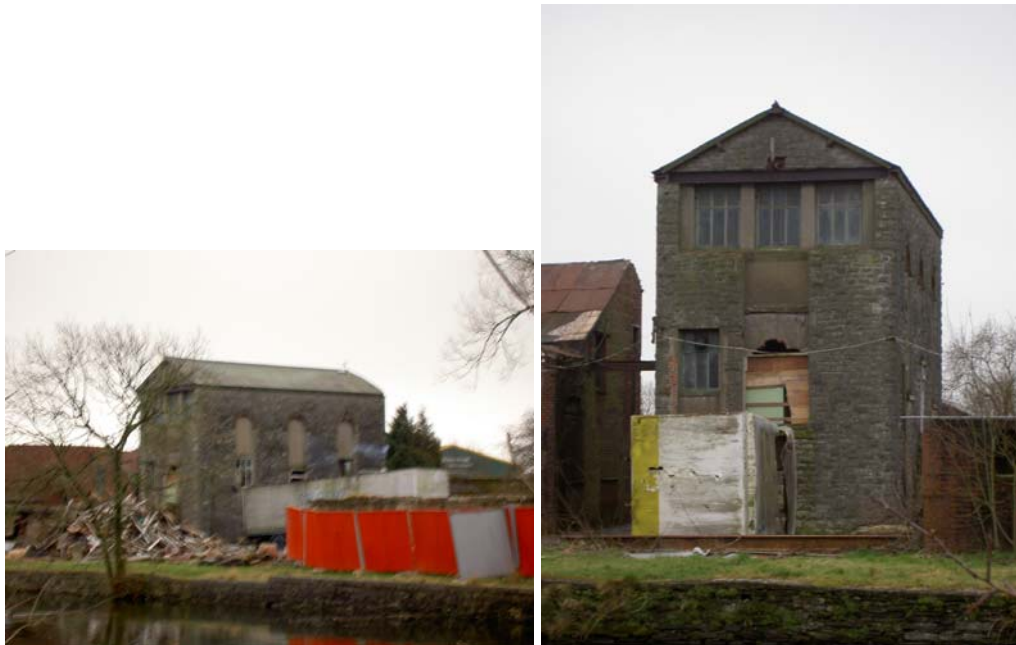
Site Number: 57**Address:** Canal Side**Current use:** Empty**Preservation:** 2**Condition:** Poor**Statutory designation:** None**Architectural quality (defined by CACA):** Not examined

Description: Three storeys, coursed limestone blocks with rusticated quoins. The front (north-west) elevation has a row of central loading doorways and a second floor row of windows with an iron lintel and the remains of a hoist above. On the first floor there is another high-level doorway. The north elevation has three tall windows with rounded heads, suggesting this was actually an engine house. It currently has a planning application for conversion to a house.

North external elevation (left) and front (north-west) external elevation (right)

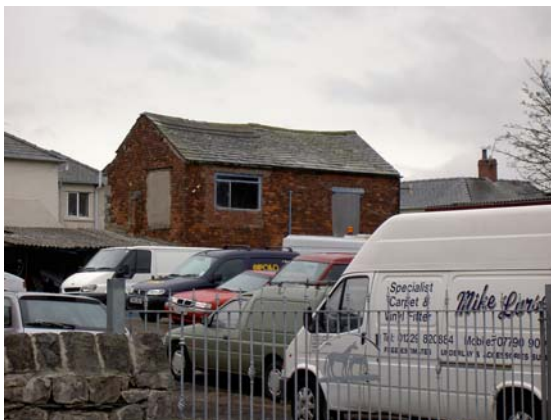
Site Number: 68**Address:** Lund Road**Current use:** Unknown**Preservation:** 3**Condition:** Poor**Statutory designation:** None**Architectural quality (defined by CACA):** Not examined

South and west external elevations
