A SURVEY OF WAREHOUSES IN ULVERSTON, CUMBRIA

During March 2005 it was decided to undertake a rapid survey of all of the identifiable warehouses and warehouse-like buildings in Ulverston. The aim of the survey was to identify how many of this type of building exist, what condition they are in, what uses they are put to and their distribution within the town. A gazetteer of all of the sites was compiled and photographs were taken. A brief amount of analysis was carried out of the results and a short historical background prepared in order to put them into context.

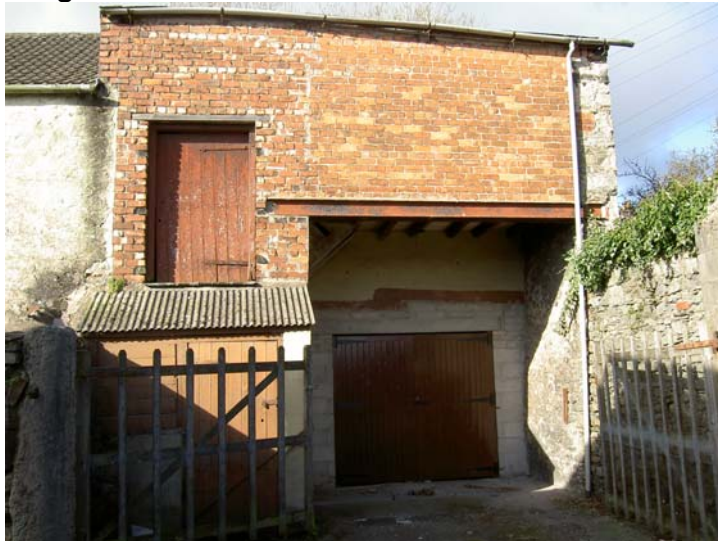
Description: Brick, English garden wall bond, two-storey, with high-level loading door on south side of east elevation. North side of east elevation has been extensively rebuilt in brick, possibly to accommodate a large doorway (presumably accessing garden to west) added on the ground floor, but has limestone quoins on north-east corner. Small mono-pitch outshut added to south end of ground floor of east elevation, below first-floor door.

East external elevation

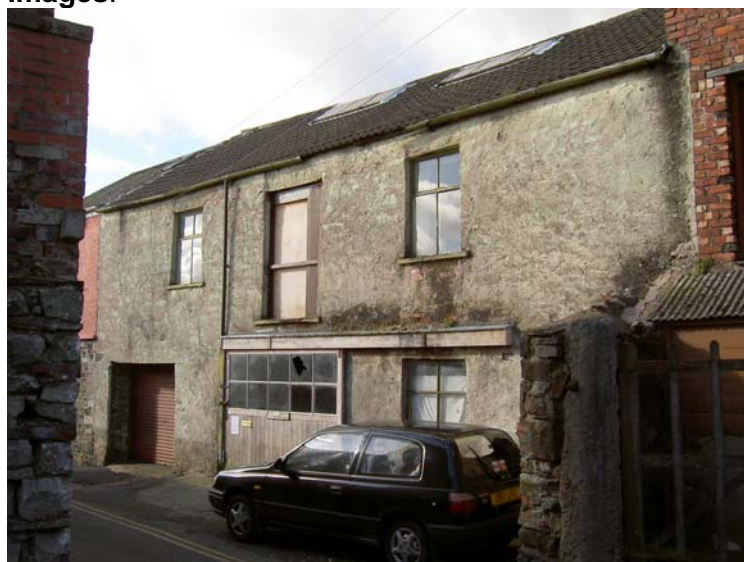
Site Number: 02

Description: Rendered but probably stone, two-storey. Two large ground floor doorways, one with sliding door, and ground floor window in east elevation. Window on south side of first floor of east elevation, and loading door in centre. Further window on north side of first floor, east elevation, was originally a second loading door, partially blocked with brick. Internally the roof is constructed with hand-finished timbers forming simple tie-beam trusses. There is a current planning application for conversion to two dwellings.

East external elevation

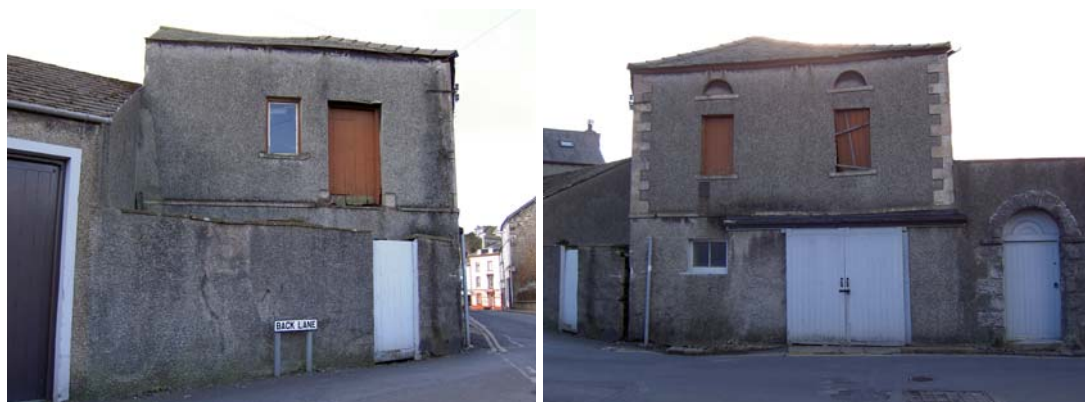
Site Number: 03

Description: Rendered with quoins and string course, two storey, hipped roof. North-west (front) elevation has symmetrical first floor windows (boarded up) with semi-circular overlights. Ground floor has wagon doorway and small window to left. North-east elevation has small first floor loading doorway and windows on first and ground floor.

North-east external elevation (left), north-west (front) external elevation (right)

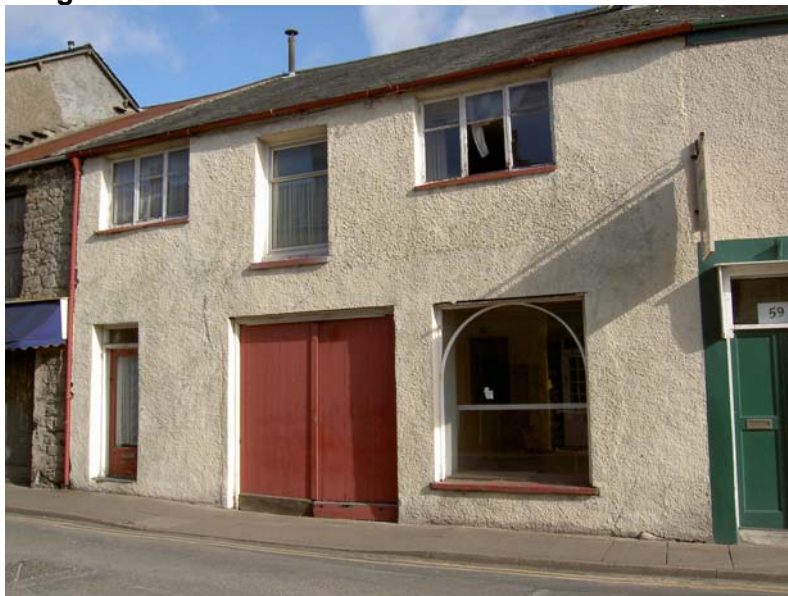
Site Number: 07**Address:** Market Street**Current use:** Empty**Preservation:** 4**Condition:** Fair**Statutory designation:** Within Conservation Area**Architectural quality (defined by CACA):** Adverse

Description: Two storey, rendered. South-west (front) elevation has two large (inserted?) first floor windows either side of a central window, which may have originally been a loading door. Ground floor has large shop window on south-east side and central (inserted?) wagon doorway, with pedestrian doorway to south-west. North-east (rear) elevation has two first floor windows, and a ground floor window and pedestrian doorway. Internally it has been much altered for use as a garage. The first floor has added partition walls forming rooms and the ground floor has inserted iron columns supporting the floor, making a large open space. It recently had a planning application for conversion to dwellings, although the current status of this is unknown.

South-west (front) external elevation

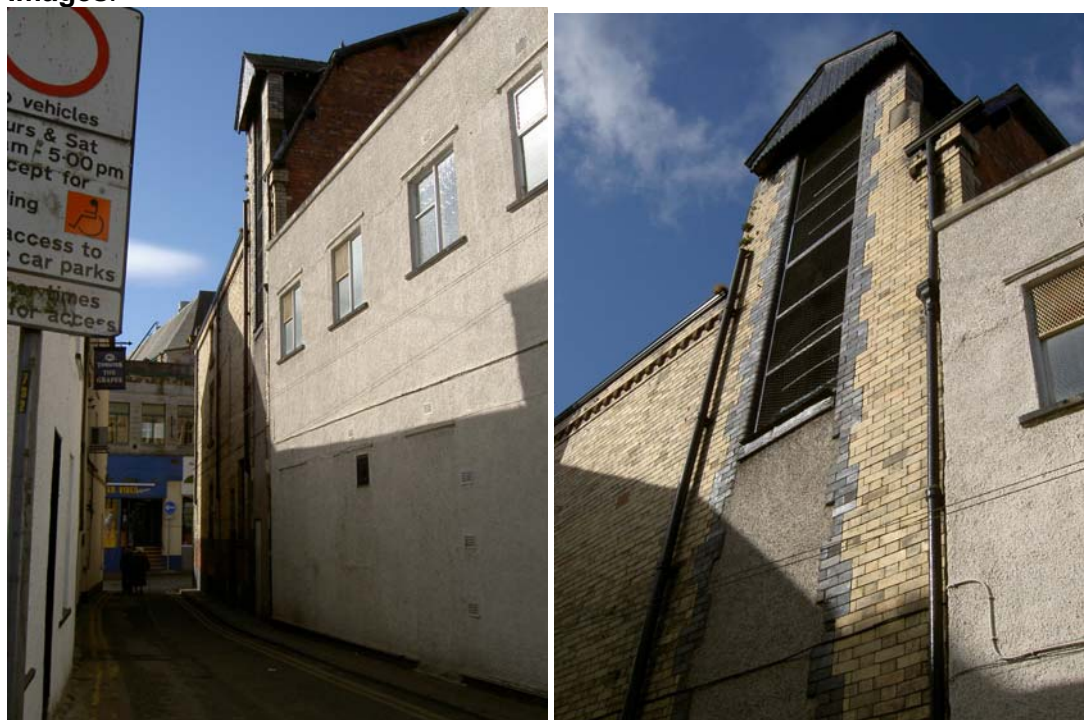
Site Number: 10**Address:** The Weint**Current use:** Business (shop)**Preservation:** 1**Condition:** Good**Statutory designation:** Within Conservation Area**Architectural quality (defined by CACA):** Positive

Description: Three storey, brick built, forming part of much larger Co-Op building dated 1881 (Turnbull and Southern 1995, 7). The warehouse section is tall and narrow with several apertures or a single tall aperture, the lower part of which is blocked. The gabled canopy covering the hoist is still *in situ*.

East (front) external elevation

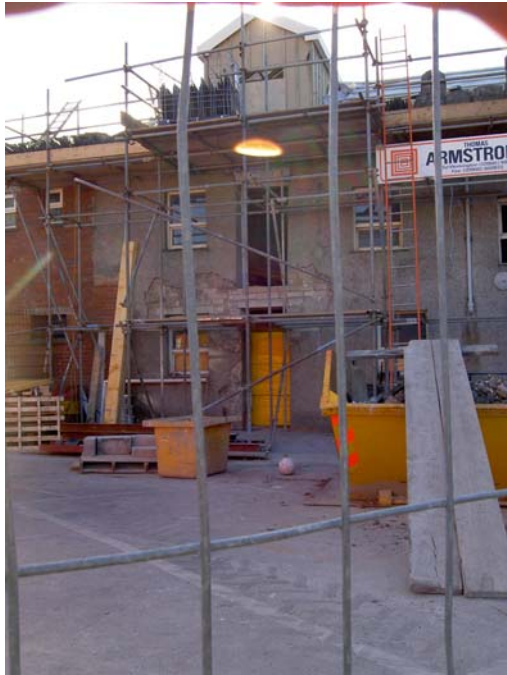
Site Number: 12**Address:** Lower Brook Street - Buxton Place**Current use:** Domestic**Preservation:** 4**Condition:** Fair**Statutory designation:** Within Conservation Area**Architectural quality (defined by CACA):** Not examined**Description:** Two storey with dormer gable containing hoist. Rendered but extensively rebuilt. Part of larger building including Site 13. North (front) elevation has central loading doorways on all floors with pairs of flanking windows. Currently being redeveloped for housing.**Images:**

North (front) external elevation

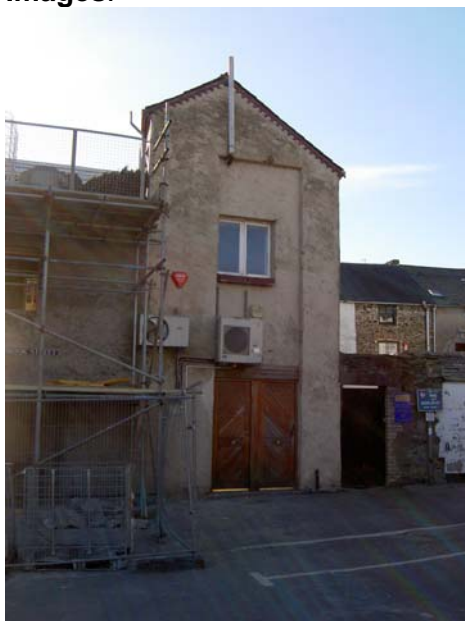
Site Number: 13

Condition: Poor

Description: Three storey, rendered. The north (front) elevation forms an asymmetrical gable with blocked, off-centre loading doorways on all floors. The ground floor doorway is not blocked and the first floor doorway has been partially used as a window. It is about to be redeveloped for housing.

North (front) external elevation

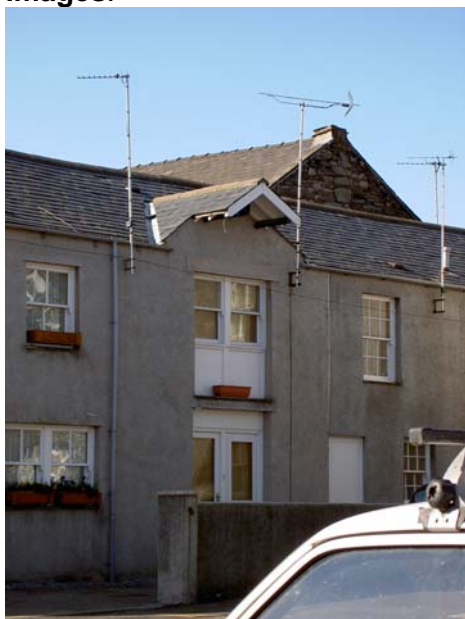
Site Number: 14**Address:** Smith's Court**Current use:** Domestic**Preservation:** 4**Condition:** Good**Statutory designation:** Within Conservation Area**Architectural quality (defined by CACA):** Neutral

Description: Two storeys, rendered, with gabled canopy covering site of hoist. Extensively modernised or even entirely rebuilt, and may be a modern copy of a warehouse. Large loading doors on ground and first floor of north (front) elevation converted to windows, with smaller flanking windows.

North (front) external elevation

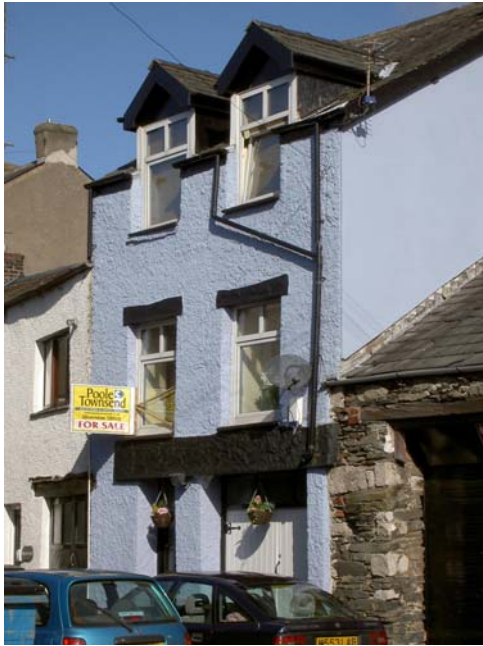
Site Number: 15**Address:** Buxton Mews**Current use:** Domestic**Preservation:** 3**Condition:** Good**Statutory designation:** Within Conservation Area**Architectural quality (defined by CACA):** Adverse

Description: Rendered, two storeys with gabled dormers. Windows on first and attic floor of front (south) elevation and a pedestrian doorway in the ground floor and a garage doorway to the east. Probably not a warehouse, but the dormer windows and large windows on the first floor could be converted loading doorways. Currently for sale.

South (front) elevation

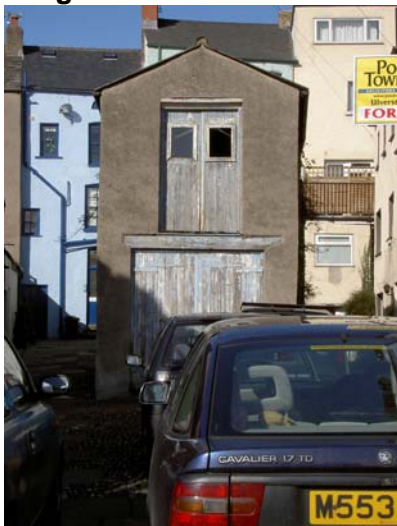
Site Number: 16**Address:** Buxton Mews**Current use:** Unknown**Preservation:** 3**Condition:** Fair**Statutory designation:** Within Conservation Area**Architectural quality (defined by CACA):** Not examined**Description:** Small, two storey building, rendered. First floor loading doorways in the east (front) gable elevation with a larger wagon doorway below (possibly inserted). There are additional windows and pedestrian doorways in the north and south elevations.**Images:**

East (front) external elevation

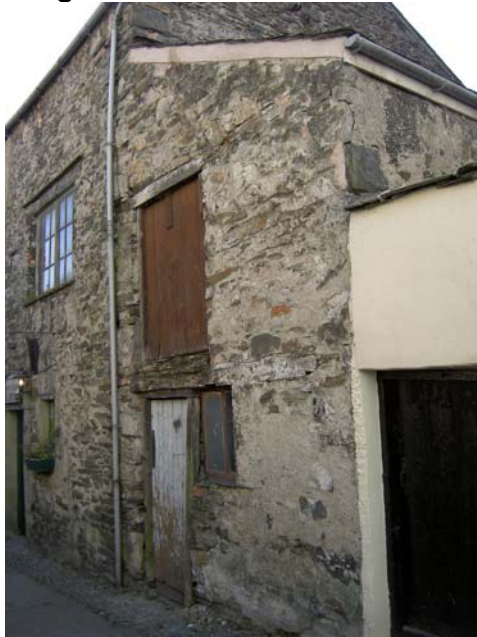
Site Number: 17**Address:** Buxton Mews

Condition: Poor

Description: Small two storey building, effectively just a large monopitch outshut attached to the larger building to the east. It is built of random coursed slate rubble, with a thin coat of render, and has a small loading doorway at first floor level and a pedestrian doorway below.

North (front) external elevation

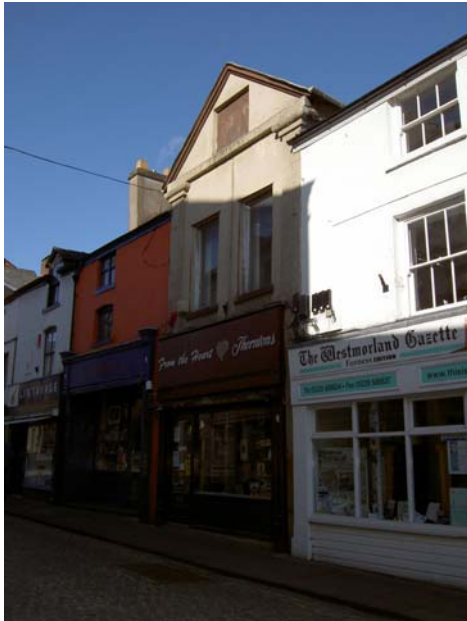
Site Number: 18

Condition: Fair

Description: Two storeys with attic, rendered, decorated with engaged pilasters and a string course. The south (front) elevation has a blocked central aperture at attic level, which may be a loading doorway, although it is very small, and there are two wide and tall windows below this, which could also have been loading doorways. The ground floor is filled by a shop front.

South (front) external elevation

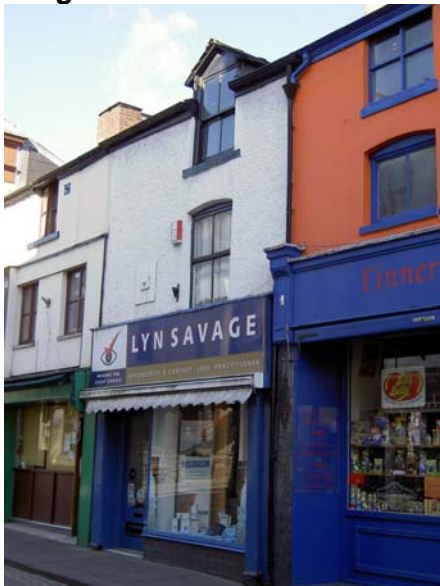
Site Number: 19

Condition: Good

Description: Two storey with attic, rendered. In the south (front) elevation the attic has a dormer window, which may have housed a loading door although this seems unlikely. There is another window below this and a shop front on the ground floor.

South (front) external elevation

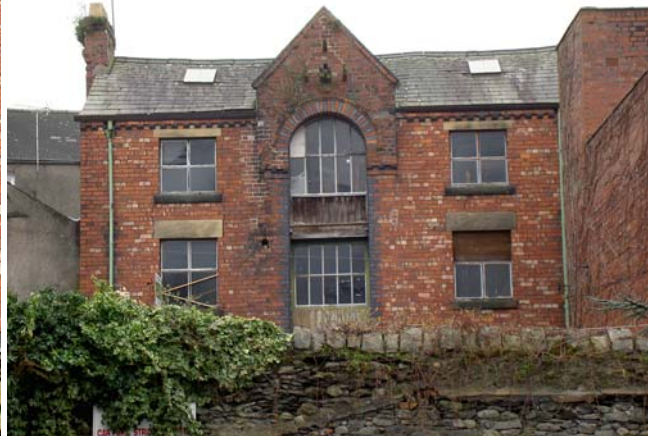
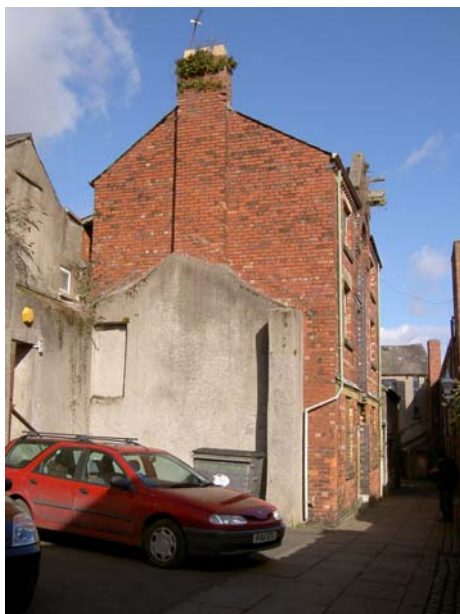
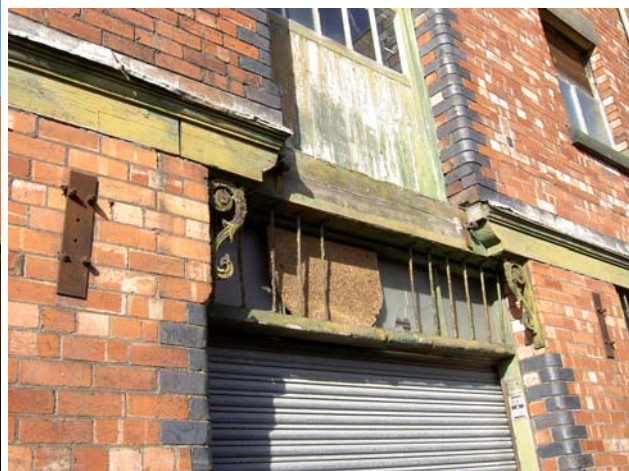
Site Number: 20

Condition: Fair

Description: Three storey, brick. There are central loading doorways on each floor in the front (east) elevation beneath a round arch and a blind dormer, with the remains of the hoist, flanked by a pair of windows. At ground floor the sill of the first floor loading doorway is supported by a timber beam with scrolled corbels and a pair of elaborate cast iron brackets. There is evidence for subsidence cracks below several of the windows on the south side. The end wall of a smaller building, including its extant chimney, are visible against the south elevation. It is currently for sale and formed the back of a shop (Fletcher and Robinson) on Queen Street.

South external elevation (left) and detail of iron brackets (right)

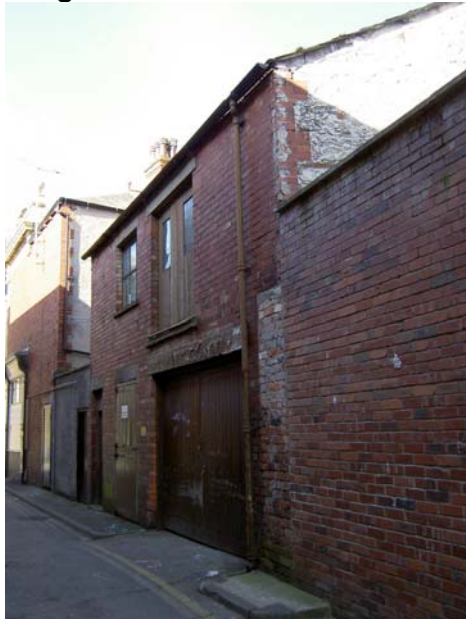
Site Number: 21**Address:** Between Brogden Street and New Market Street**Current use:** Storage**Preservation:** 1**Condition:** Fair**Statutory designation:** Within Conservation Area**Architectural quality (defined by CACA):** Neutral**Description:** Small, two storeys, brick, probably refronting stone. There is a loading doorway at first floor level and a small window in the south (front) elevation, with a large wagon doorway and pedestrian doorway on the ground floor.**Images:**

South (front) external elevation

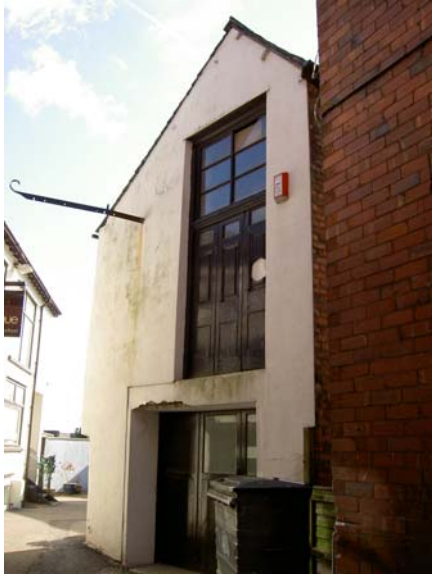
Site Number: 22**Address:** Off Brogden Street**Current use:** Unknown**Preservation:** 2**Condition:** Fair**Statutory designation:** Within Conservation Area**Architectural quality (defined by CACA):** Adverse**Description:** Two or three storeys, rendered, brick. The north (front) elevation forms an asymmetrical gable with off-centre loading doorways on all floors, the ground floor doorway having been made wider. Currently being redeveloped.**Images:**

North (front) external elevation

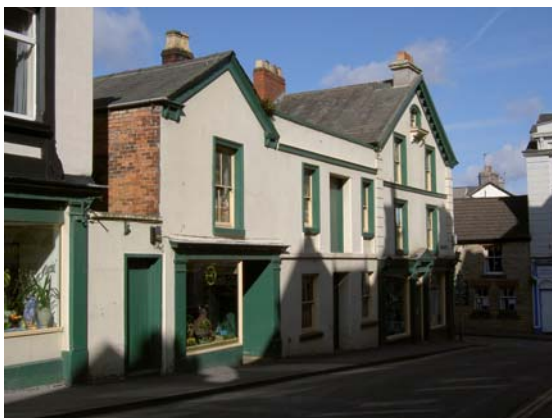
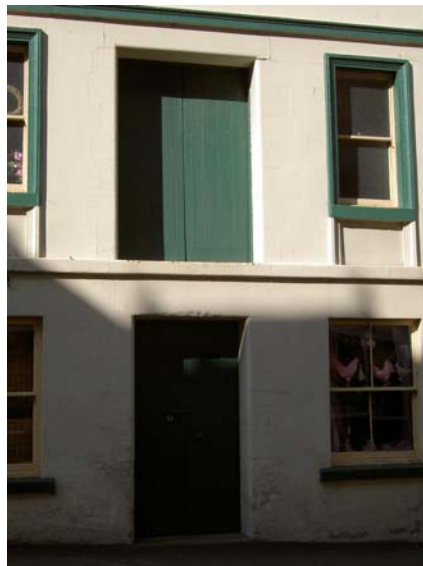
Site Number: 23**Address:** Brogden Street**Current use:** Business (shop: Dodd's Florist)**Preservation:** 1**Condition:** Good**Statutory designation:** Within Conservation Area; Listed**Architectural quality (defined by CACA):** Listed

Description: Central part of much larger building made up of three two and three storey blocks. It is probably all brick, rendered and scored to give the appearance of ashlar blocks. The central section is two storeys, with a central loading doorway on the first floor above a pedestrian doorway in the east (front) elevation, flanked on both floors by windows.

East (front) elevation (left) and detail of loading doorway (right)

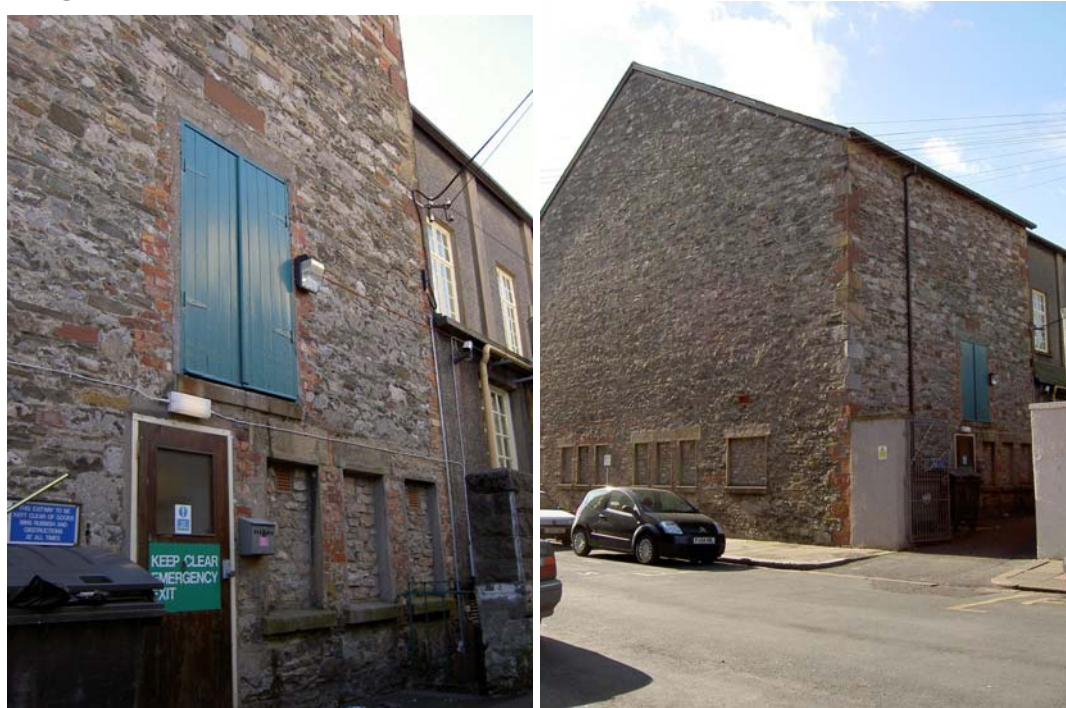
Site Number: 24**Address:** Brogden Street

Condition: Fair

Description: The rear (east) end of the Coronation Hall shows signs of three phases of construction, one on top of the other. The lowest is built of mixed rubble with dressed sandstone quoins, the next has limestone quoins and the highest has rougher pecked sandstone quoins. This third phase seems to relate to the insertion of a row of windows on the ground floor of the east and north elevations and a high level loading doorway in the north elevation. These three phases may correspond to the building's use as a mansion (Littlecroft), mansion and then Hotel (Lightburn House/County Hotel - burnt down in 1911) and the Coronation Hall (Ashburner 1993, 22; Birkett 1949, 129). The doorway was presumably inserted to serve the stage end of the Coronation Hall.

North external elevation (left) and rear (east) elevation

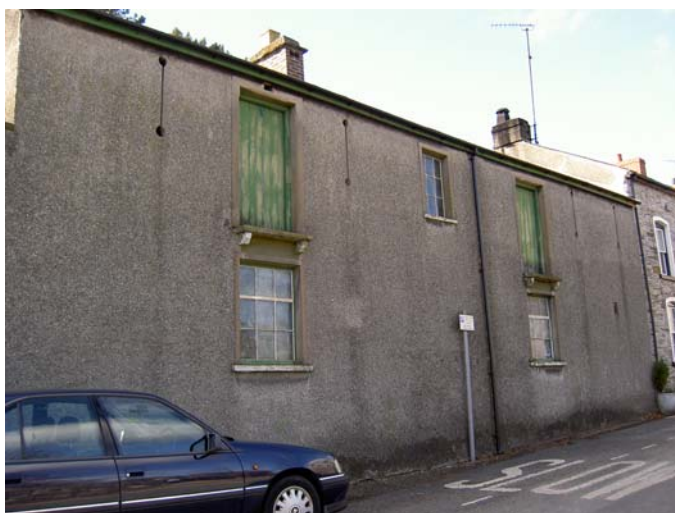
Site Number: 25

Condition: Fair

Description: Two storeys, rendered. The north (front) external elevation has a pair of loading doorways on the first floor, the sills of which rest on scrolled stone corbels, above windows. There is a further window on the first floor and looped ventilation slots. There are two chimneys.

North (front) external elevation

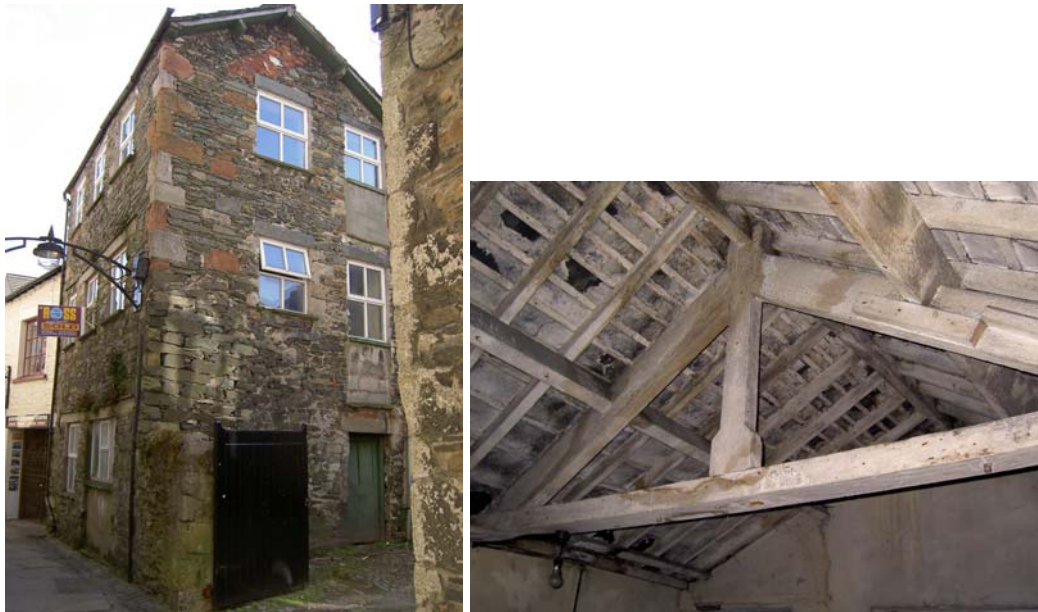
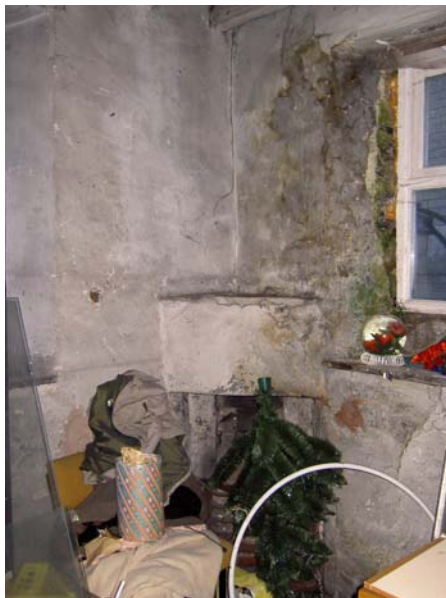
Condition: Poor

Description: Three storey, mix of randomly coursed slate and brick with some evident rebuilding in brick for the addition of a chimney (since removed). The building appears to have been extended in height, probably from one storey, and possibly originally formed part of the building to the south. The north (front) elevation has three windows on the first and second floors, one on the ground floor adjacent to a partially blocked large pedestrian doorway. The west elevation has two partially blocked loading doorways on the south side of the first and second floors above a pedestrian doorway. Internally the roof structure consists of a single king-post truss and there is a fireplace in the north-west corner of the first floor. It was recently subject to a planning application for conversion to housing.

North (front) and west external elevations (left) and king post truss (right)

Corner fireplace on first floor

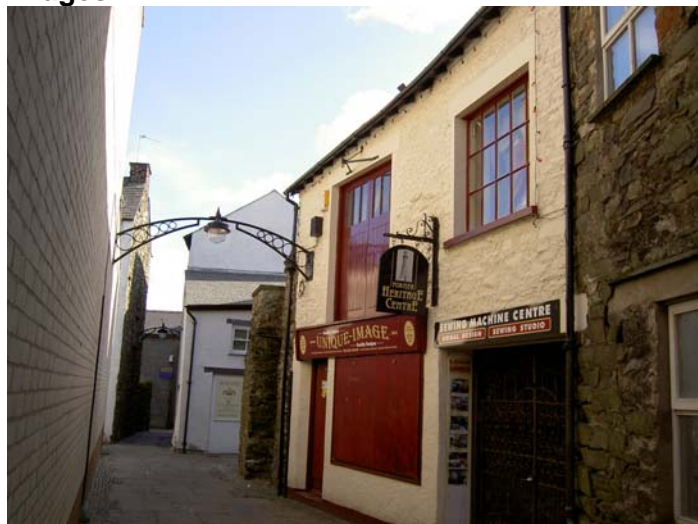
Site Number: 29**Address:** Lower Brook Street**Current use:** Business (shop: Unique Image (old Heritage Centre))**Preservation:** 2**Condition:** Good**Statutory designation:** Within Conservation Area; Listed**Architectural quality (defined by CACA):** Listed**Description:** Two storeys, rendered. Large loading door on first floor of front (north) elevation above a large shop window and pedestrian doorway. To the west is another large window on the first floor above a large aperture forming a passage into the yard to the south.**Images:**

North (front) external elevation

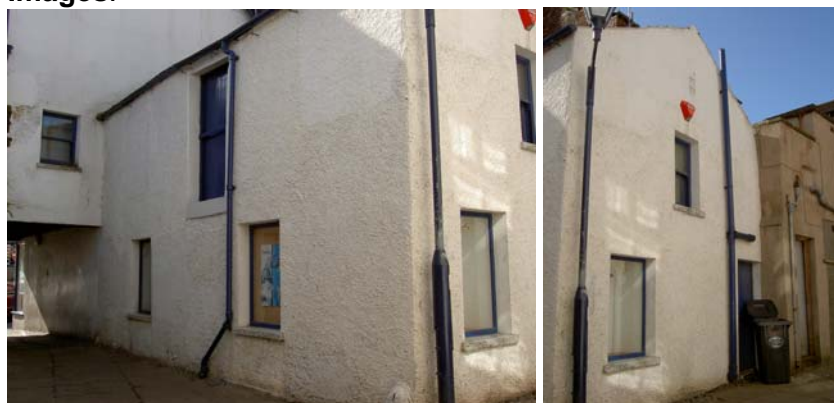
Site Number: 30**Address:** Lower Brook Street (Brazier Fell's Yard)**Current use:** Business (shop: formerly WF Sport, now empty)**Preservation:** 3**Condition:** Good**Statutory designation:** Within Conservation Area**Architectural quality (defined by CACA):** Neutral**Description:** Two storey extension to rear (north) of shop facing onto Market Street, rendered. There are several small windows on both floors, a first floor loading doorway in the east elevation and a pedestrian doorway in the north elevation.**Images:**

East external elevation (left) and north external elevation (right)

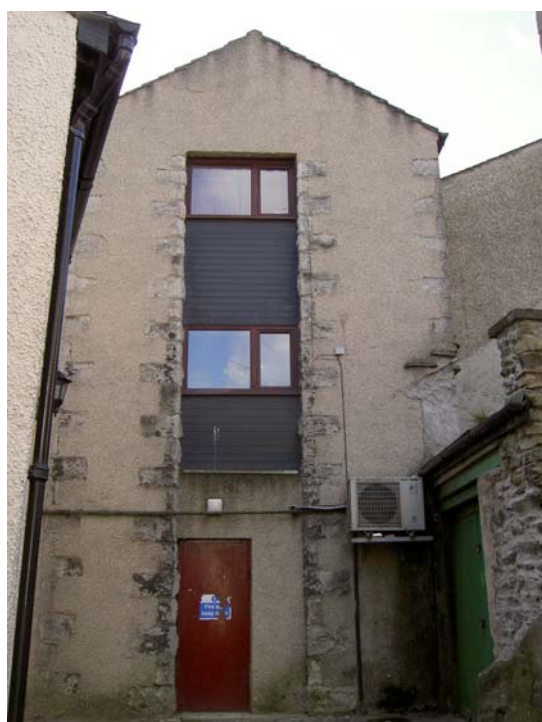
Site Number: 31**Address:** Brazier Fell's Yard**Current use:** Domestic**Preservation:** 2**Condition:** Fair**Statutory designation:** Conservation Area; Listed**Architectural quality (defined by CACA):** Listed

Description: Rear part of a larger shop fronting onto Market Street (the whole of which is Listed). It is rendered and three-storeys with a single large central aperture, original loading doors, blocked to form first and second floor windows and a ground floor doorway. The surrounds of the original aperture are finished with dressed limestone quoins as are the corners of the building.

Front (north) external elevation

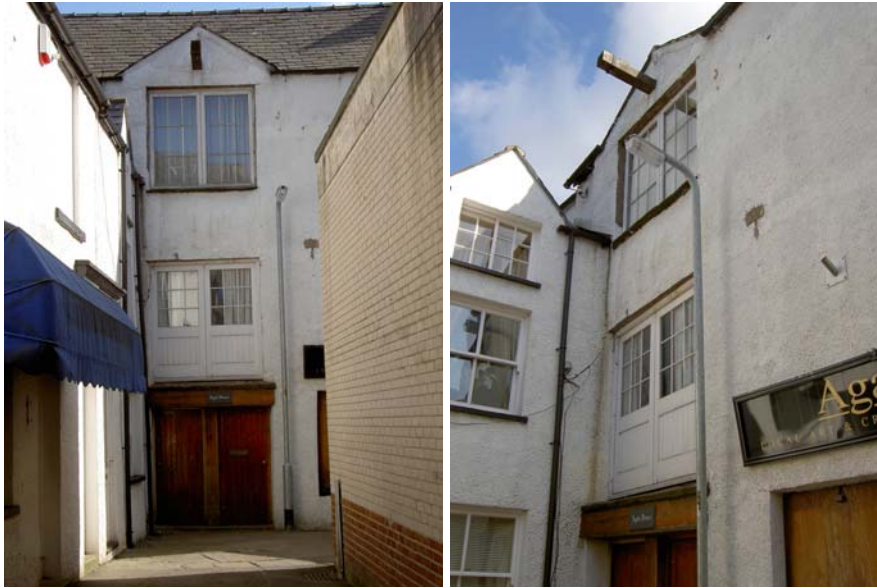
Site Number: 32**Address:** Bolton's Place**Current use:** Domestic/business (shop: Agate House)**Preservation:** 2**Condition:** Good**Statutory designation:** Conservation Area**Architectural quality (defined by CACA):** Neutral

Description: Three storeys, rendered. Row of central apertures, which have been made into windows on first and second floor and a large doorway on the ground floor. A beam projects from above the second floor window, and is presumably part of the original hoist. The warehouse forms part of a much larger building, which is partially used for housing and partially for a shop.

Front (west) external elevation

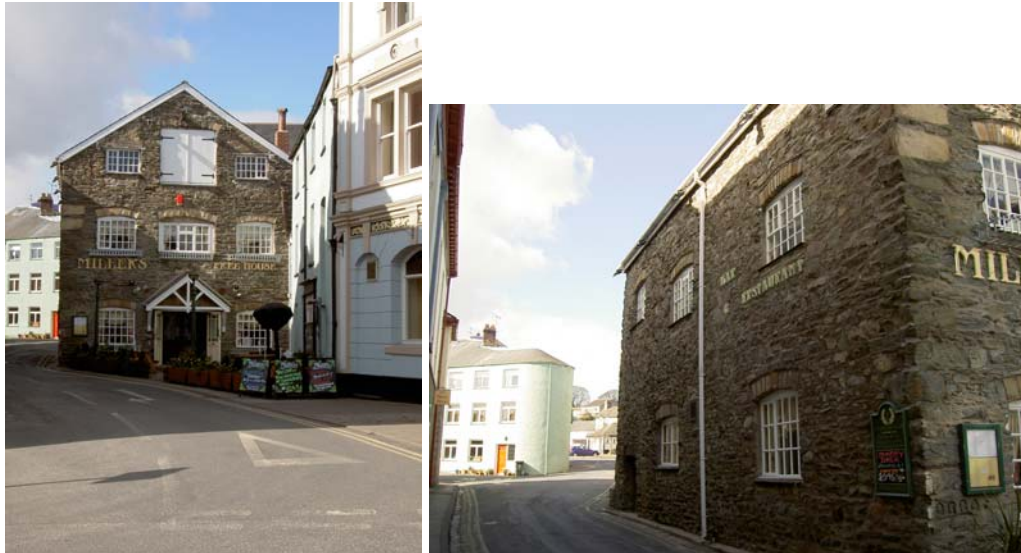
Front (east) external elevation (left) and south external elevation (right)

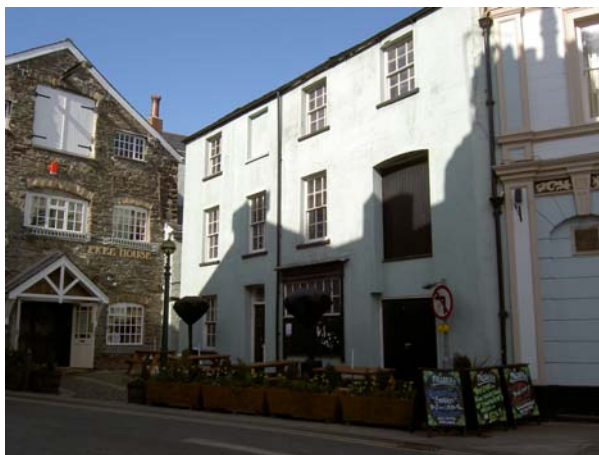
Condition: Poor

Description: Three storeys, rendered and painted. The front (south) elevation has four second floor windows, three on the first floor and one on the ground floor. There are a pair of loading doorways on the east side, first and ground floor, and a pedestrian doorway in the centre of the ground floor. Between the ground floor doorways is a partially covered multi-light shop window with a moulded entablature.

Front (south) external elevation

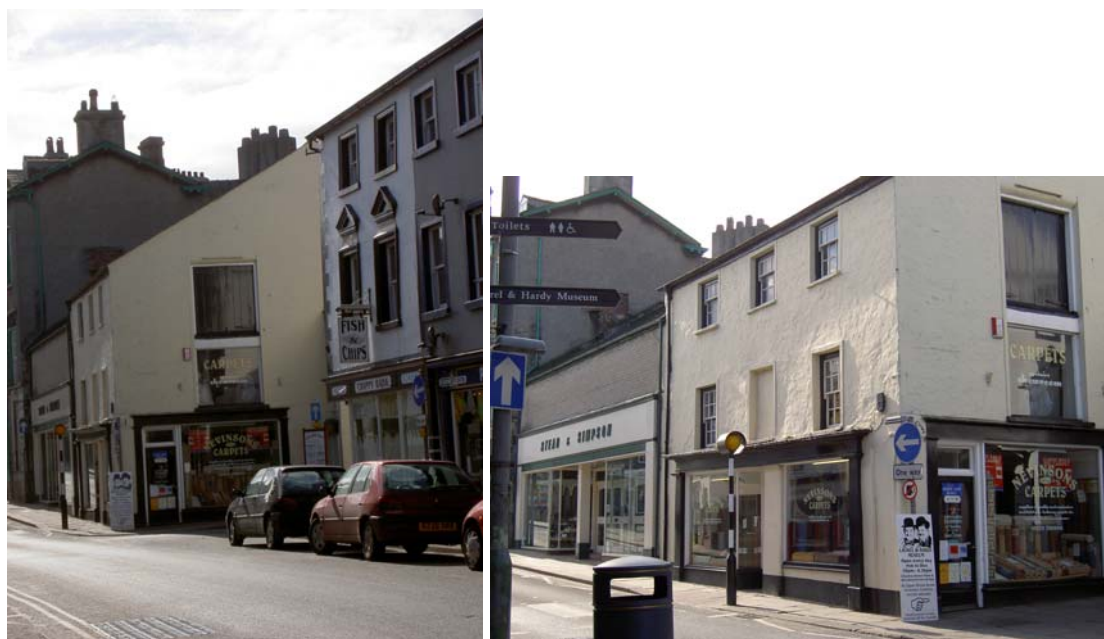
Description: Three storey shop with loading doorways in north elevations, rendered and painted. Front (east) elevation has three windows per first and second floor and a large shop window on ground floor. North elevation has remaining second floor loading doorway and window below (probably originally a second loading doorway). On the ground floor there is a smaller shop window with a pedestrian doorway to the east of the apertures above.

North external elevation (left) and front (east) and north external elevations (right)

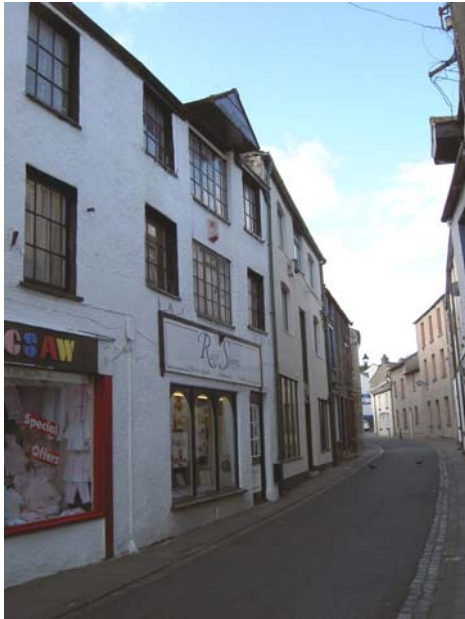
Description: Three storeys, rendered and painted. The first and second floors have two windows either side of wider central windows that were probably originally loading doorways. A timber gabled canopy, which probably originally housed/covered the hoist forms a small dormer at roof level.

North-east external elevation (front)

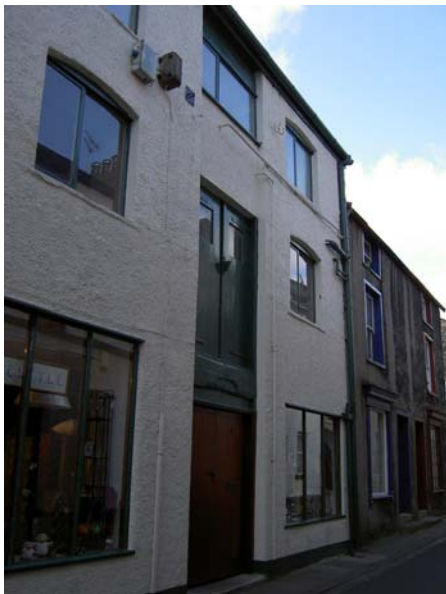
Site Number: 39**Address:** Upper Brook Street**Current use:** Business (shop: Home Style)**Preservation:** 2**Condition:** Good**Statutory designation:** Conservation Area**Architectural quality (defined by CACA):** Neutral**Description:** Three storeys, rendered and painted. A similar arrangement to Sites **38** and **40**, with a row of central apertures, one of which retains the original loading doors (first floor), flanked by pairs of windows. The second floor aperture has been converted into a window.**Images:**

North-east external elevation (front)

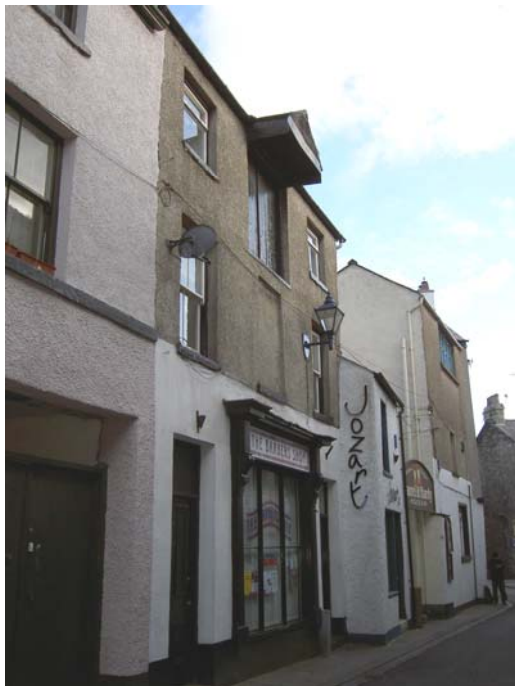
Site Number: 40**Address:** Upper Brook Street**Current use:** Business (shop: Russ the Barber)**Preservation:** 2**Condition:** Good**Statutory designation:** Conservation Area**Architectural quality (defined by CACA):** Positive

Description: Three storeys, rendered, similar arrangement to Sites 38 and 39. Flanking pair of windows on the first and second floors of the south-west elevation, with a central loading doorway remaining on the second floor and another, blocked beneath. At roof level a gabled timber canopy forms a dormer roof over the position of the original hoist (which is no longer evident). On the ground floor there is a decorative shop front with a moulded entablature, and engaged pilasters, flanked by pedestrian doorways.

Front (south-west) external elevation

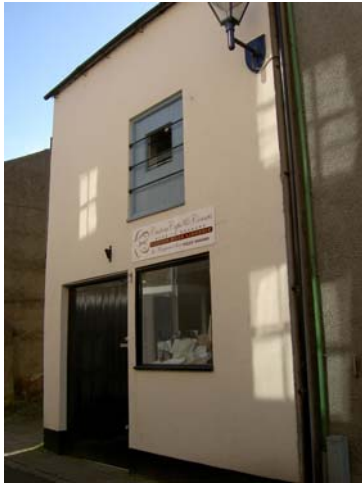
Site Number: 42**Address:** Upper Brook Street**Current use:** Business (shop: Custom Cups and Corsets)**Preservation:** 3**Condition:** Good**Statutory designation:** Conservation Area**Architectural quality (defined by CACA):** Neutral

Description: Small, two-storey shop, rendered and painted. The front (north-east) elevation has a first floor possible loading doorway off centre, with ground floor pedestrian doorway and window below.

Front (north-east) external elevation

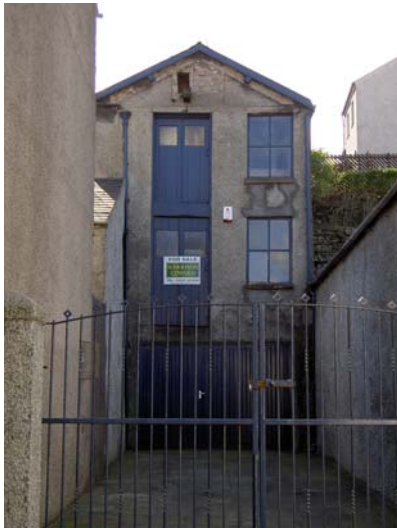
Condition: Fair

Description: Large, three storeys, rendered. Front (north-east) gable has loading doorways on the first and second floors and a large, probably inserted, doorway on the ground floor. A beam forming part of the hoist remains *in situ* above the second floor loading doorway and there are windows on the first and second floor to the right of the loading doorways. Currently for sale.

Front (north-east) external elevation

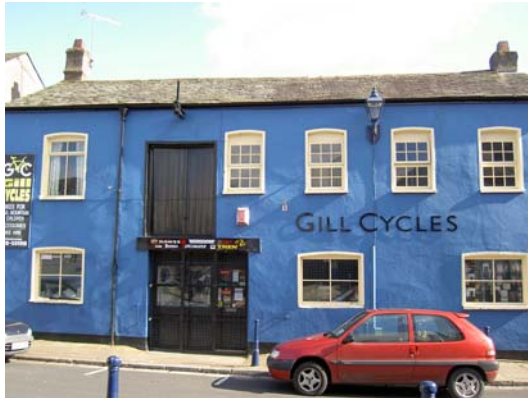
Description: Two storeys, rendered and painted. Large loading doorway on left side of front (west) elevation, with a row of windows to the right. There are two windows to the right of the ground floor and a modern doorway below the loading doorway, and a single window on the first and ground floors to the left of the doorways. The remains of an iron I-beam are present above the loading doorway, presumably forming part of the original hoist.

Front (west) elevation

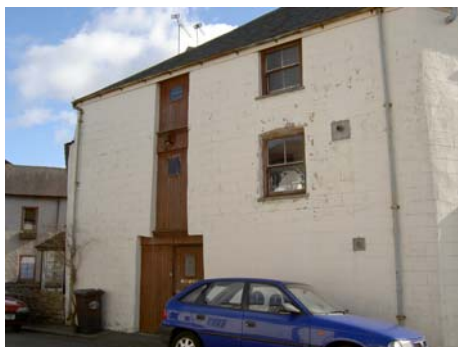
Condition: Fair

Description: Three storeys, rendered and scored to look like ashlar blocks, painted. Loading doorways, now infilled to form windows on the left side of the north elevation, with a larger (probably inserted) doorway below. A single smaller window is present on both the first and second floors to the right.

Front (north) external elevation

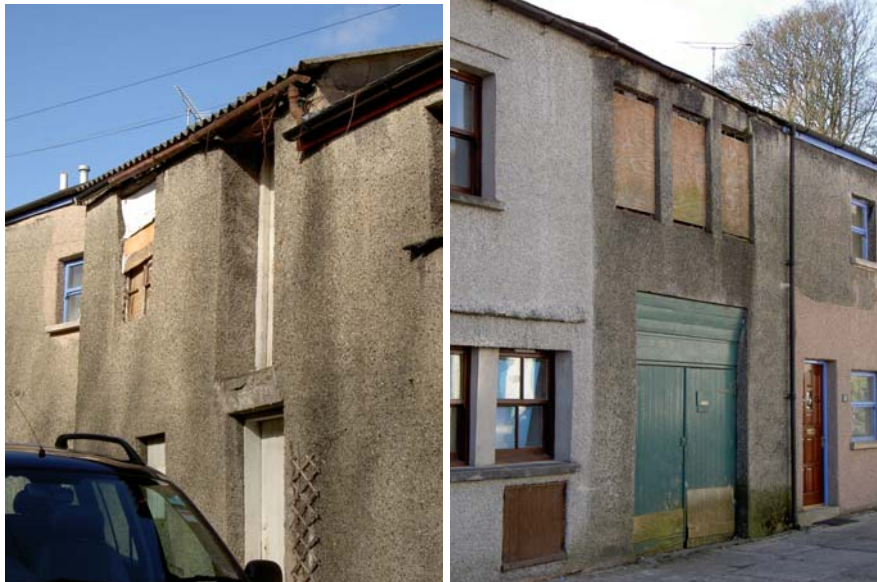
Condition: Poor

Description: Two storeys, rendered, within a row of houses. The front (north-east) elevation has a large ground floor wagon doorway and three first floor windows (boarded over). The rear (south-west) elevation has a first floor loading doorway above a ground floor pedestrian doorway.

Rear (south-west; left) and front (north-east; right) external elevations

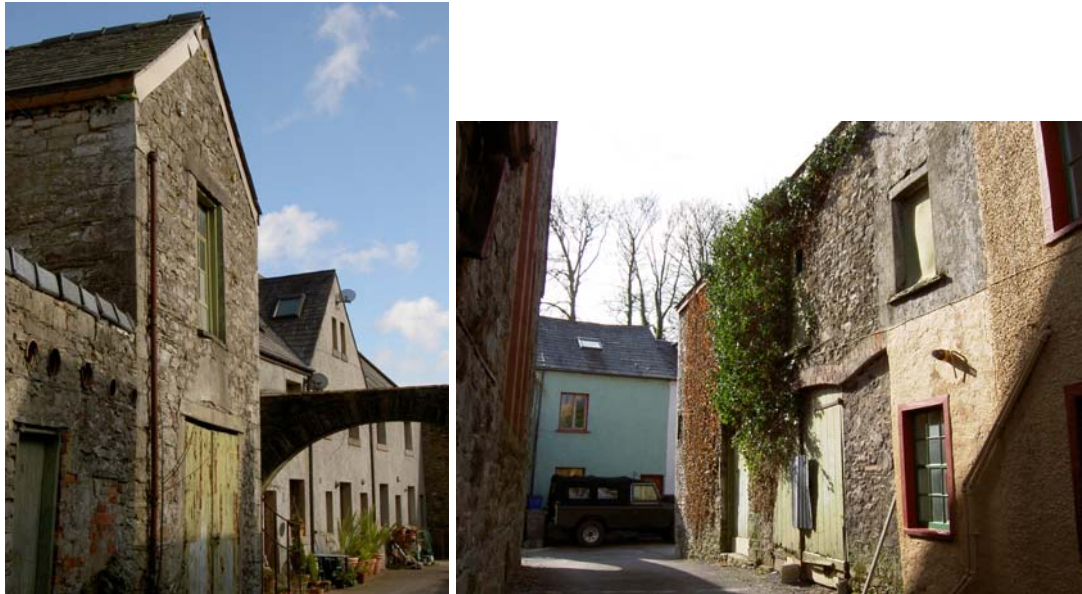
Condition: Poor

Description: Two storeys, roughly coursed stone and dressed quoins. The rear (south-west) elevation has a first floor loading doorway with a stone lintel above a ground floor wagon doorway. The south-east side has two connected doorways, one a wagon doorway, with brick arches, the smaller of which is blocked.

Rear (south-west, left) and side (south-east; right) external elevation)

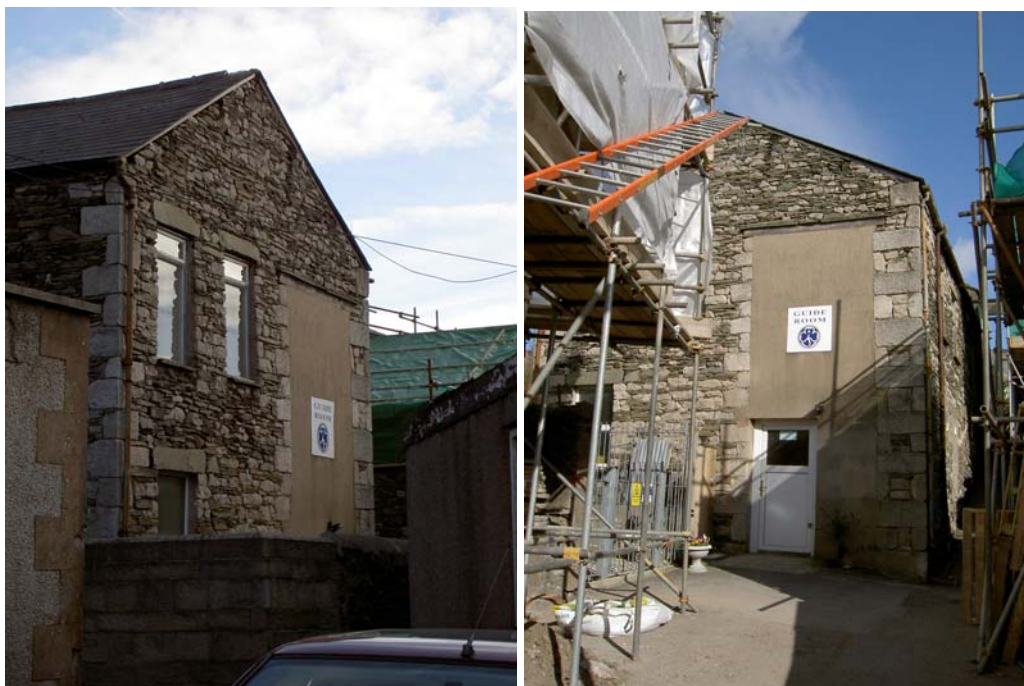
Condition: Fair

Description: Two and a half storeys, coursed stone with dressed limestone quoins. A large aperture is present on the right side, which presumably originally housed loading doors on at least two levels, but is now blocked, apart from a pedestrian doorway on the ground floor. To the left are two windows on the first floor and a doorway on the ground floor.

Front (west) external elevation

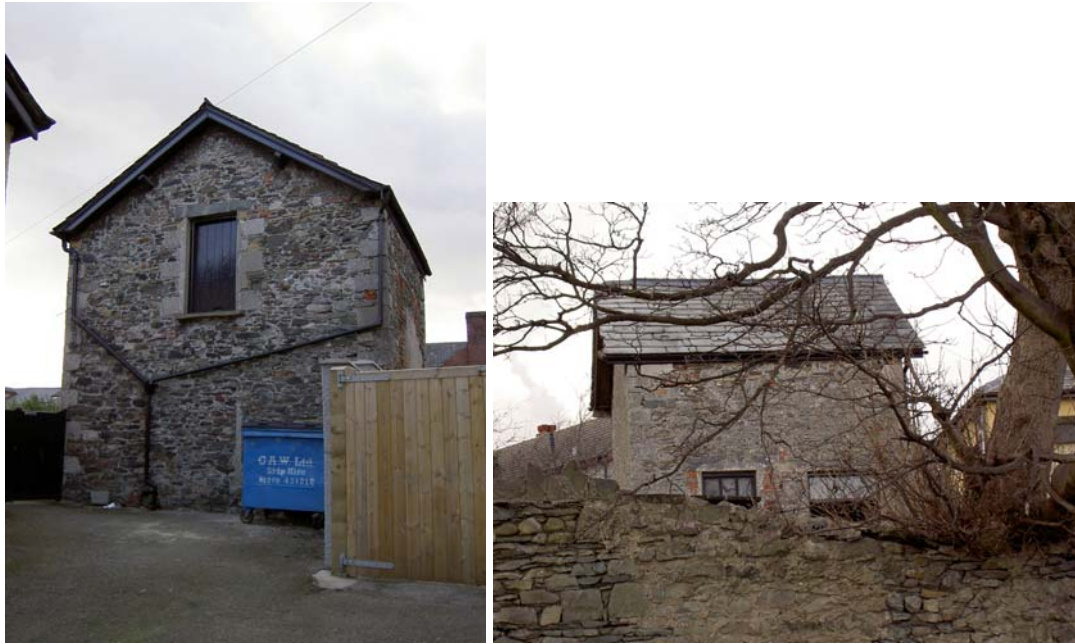
Site Number: 50**Address:** Swan Street**Current use:** Unknown**Preservation:** 2**Condition:** Fair**Statutory designation:** None**Architectural quality (defined by CACA):** Not examined

Description: Small, two-storey building, randomly coursed stone with dressed limestone quoins and a barge board. The front (east) gable has a first floor loading doorway with a stone lintel and quoins, while the south elevation has two ground floor windows, the west of which is evidently inserted.

Front (east) external elevation (left) and south external elevation (right)
