A SURVEY OF WAREHOUSES IN ULVERSTON, CUMBRIA

During March 2005 it was decided to undertake a rapid survey of all of the identifiable warehouses and warehouse-like buildings in Ulverston. The aim of the survey was to identify how many of this type of building exist, what condition they are in, what uses they are put to and their distribution within the town. A gazetteer of all of the sites was compiled and photographs were taken. A brief amount of analysis was carried out of the results and a short historical background prepared in order to put them into context.

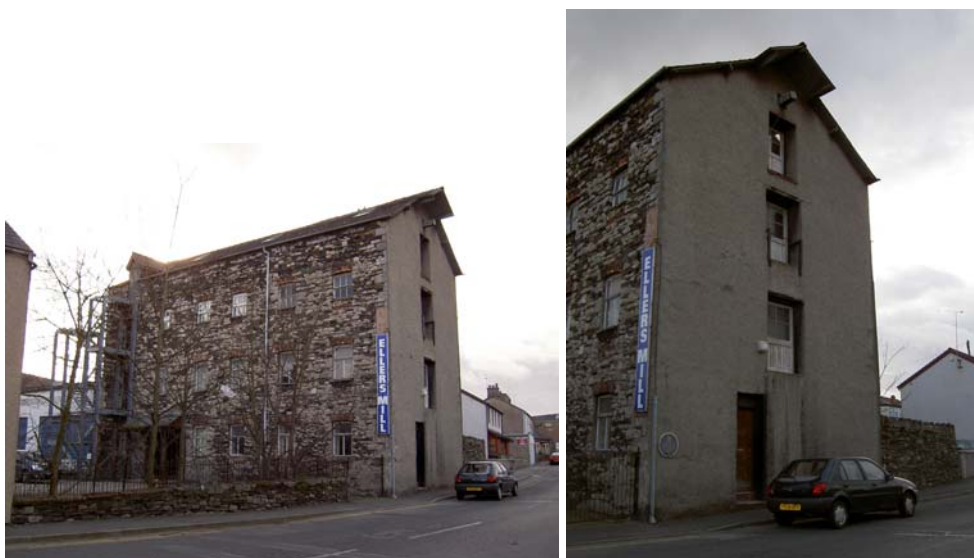
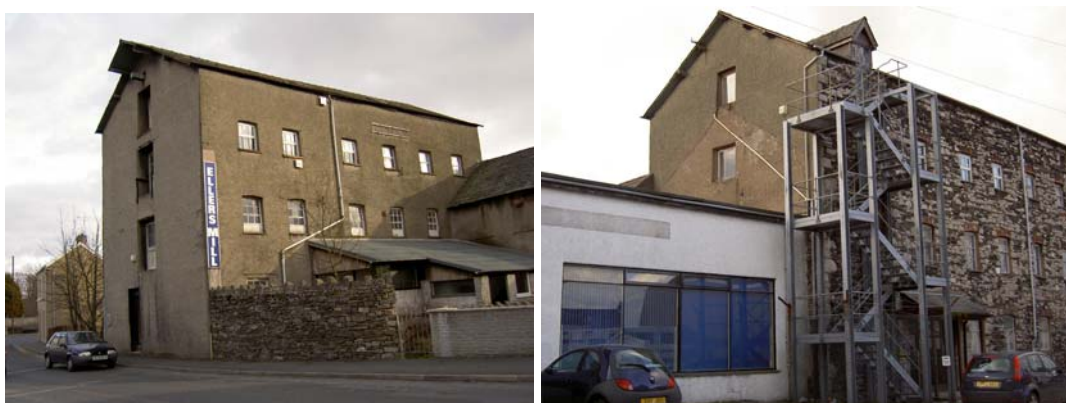
Site Number: 51**Address:** The Ellers**Current use:** Business (industrial)**Preservation:** 1**Condition:** Fair**Statutory designation:** None**Architectural quality (defined by CACA):** Adverse

Description: Large former mill, three and a half storeys, part rendered but randomly coursed stone structure. The east elevation has five windows per floor and a series of loading doorways at the south end, which have been re-used as a fire escape. A gabled hoist canopy remains *in situ*. The north elevation has a row of loading doors on all floors above the ground floor, and a pedestrian doorway on the ground floor. At the apex there is a gabled canopy over the remains of the hoist. The west elevation has six windows per floor while the south is largely obscured by attached buildings, but two windows are visible.

East external elevation (left) and north external elevation (right)

North and west external elevations (left) and south external elevation (right)

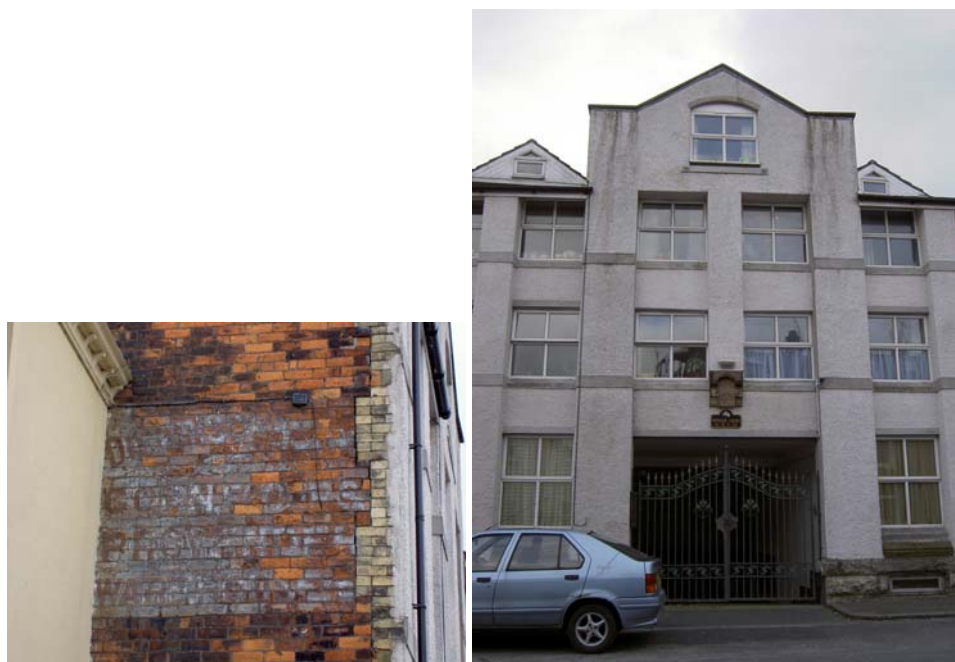
Description: Extensively modernised, rendered over brick. The front (north) elevation is a later alteration dated 1875, with various windows and a large ground floor wagon doorway and gabled dormers. The east side has a painted advertisement on its north side stating: 'Dickinson and Son[s] Cornflours Provender Warehouse[s]', and is double depth. The west and south sides are rendered and much altered.

Detail of painted advertisement on east elevation (left) and front (north) external elevation (right)

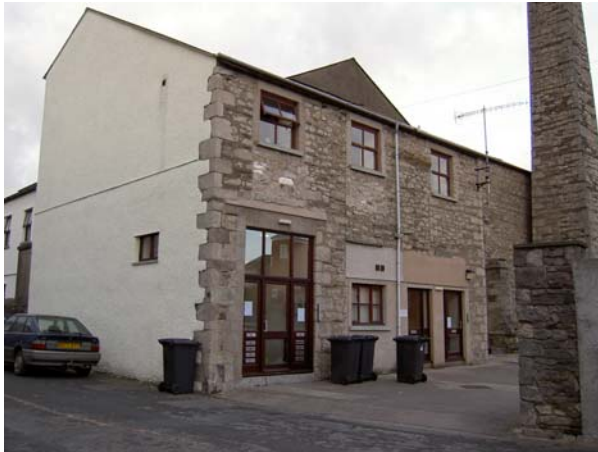
Description: Large former cotton mill, now flats. The rear (south-east) has warehouse-like elements including blocked former loading doorways at first floor level (now windows) and large wagon doorways on the ground floor.

Rear (south-east) external elevation

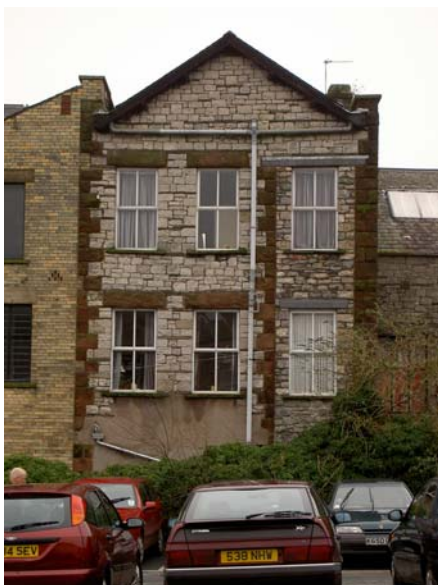
Description: Rear of a shop on New Market Street. Limestone and sandstone in regular courses of dressed blocks with sandstone quoins and details. Three storeys, forming a gable. There are a pair of windows on the first and second floors of the rear (west) elevation and the remains former loading doorways on the south side, which have been blocked and modern windows added.

Rear (west) external elevation

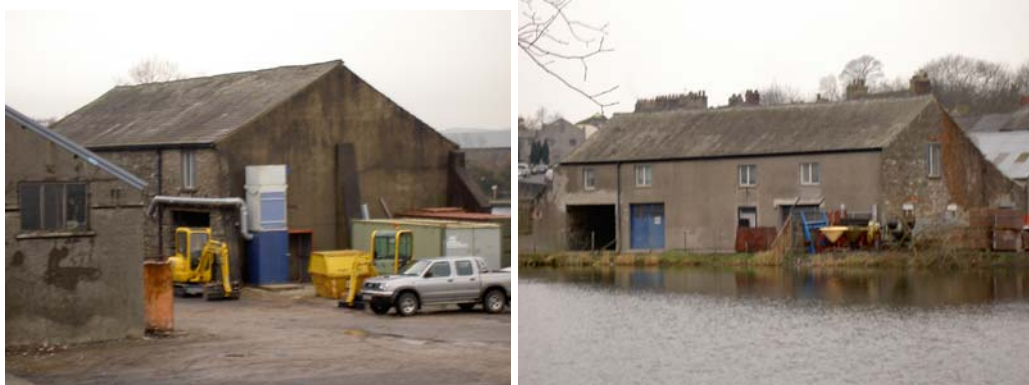
Condition: Fair

Description: Large, two storeys, part rendered but roughly coursed stone. There are numerous windows in the east elevation on the first floor and three wagon doorways on the ground floor. The north elevation has a single window at first floor level, possibly inserted and possibly originally a loading doorway. The south end has evidently been altered, probably reduced in length as the stubs of walls and buttresses are visible.

South external elevation (left) and east external elevation (right)

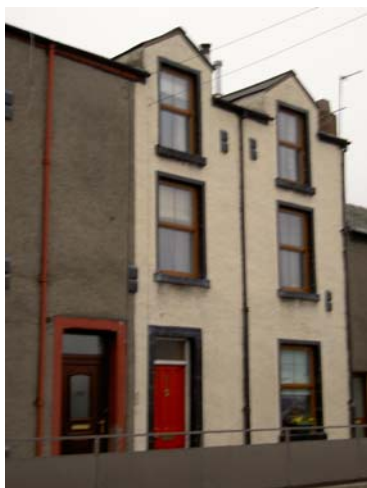
Description: Two and a half storeys, rendered and painted. Front (south-east) elevation has a pair of dormer windows on the second floor, a pair of windows on the first floor and a window and doorway on the ground floor. The windows are arguably large enough to be former loading doorways, although this is not particularly convincing.

Front (south-east) external elevation

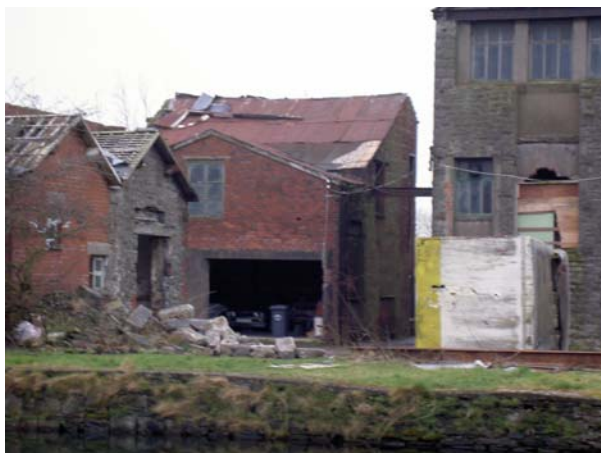
Site Number: 58**Address:** Canal Side**Current use:** Empty**Preservation:** 3**Condition:** Poor**Statutory designation:** None**Architectural quality (defined by CACA):** Not examined

Description: Brick built, two storeys. Gabled extension to north-west elevation obscures any detail but a high-level loading doorway is visible in the north elevation. Due to be demolished as part of a current building scheme.

Front (north-west) and north external elevations

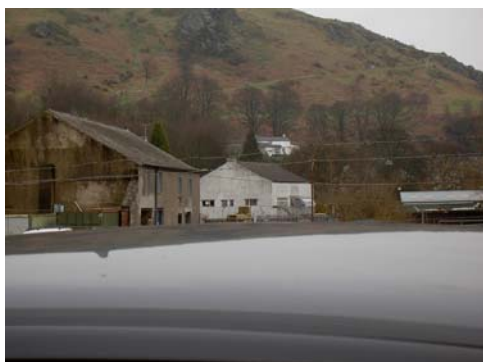
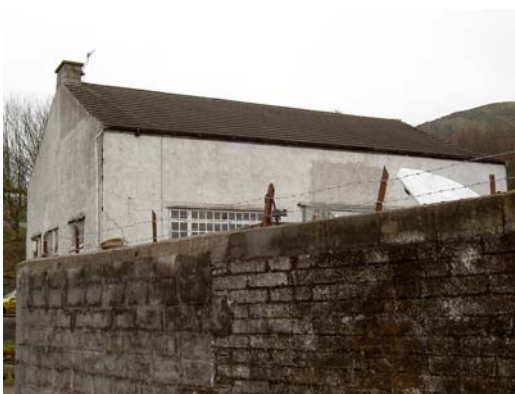
Condition: Fair

Description: Large two storey building, rendered and painted. Numerous large windows, probably inserted in all elevations, except north, on first floor and wagon doorway in ground floor of south elevation. The ground level is higher on the west side allowing access to the first floor.

South and east external elevations (left) and east external elevation (right)

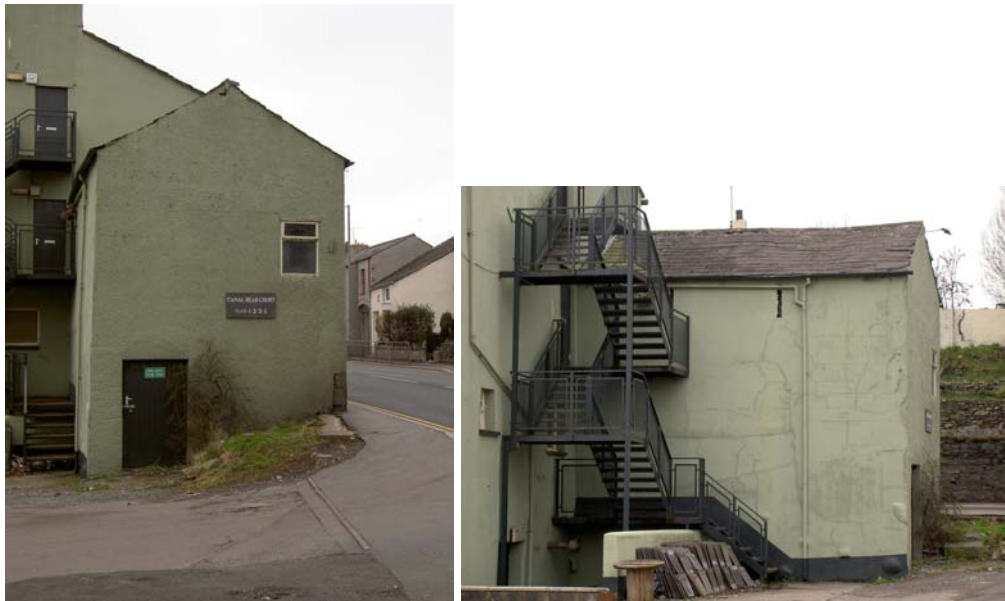
Condition: Fair

Description: Two storey extension to north-west corner of former Canal Tavern. Rendered and painted, but dressed quoins visible. North end has a single small window at first floor level and a doorway on the ground floor, both probably inserted. The east and west elevations have a pair of ventilation slots below the eaves.

North external elevation (left) and east external elevation (right)

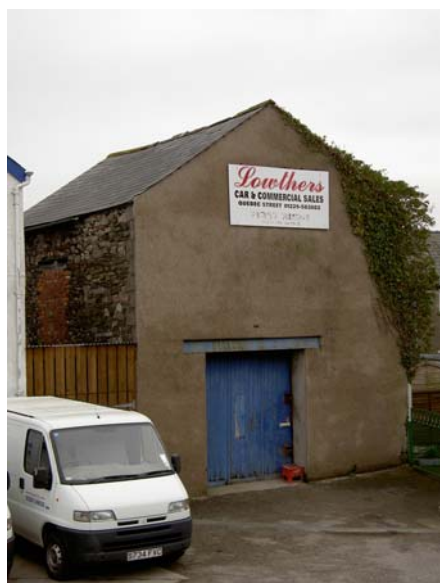
Site Number: 61**Address:** Quebec Street**Current use:** Storage/business (industrial)**Preservation:** 3**Condition:** Fair**Statutory designation:** None**Architectural quality (defined by CACA):** Not examined**Description:** Small, two-storey building. Randomly coursed stone, rendered on north-west side. Ground floor doorway in north-west elevation and blocked first floor aperture in south-west elevation, possibly former loading doorway.**Images:**

Front (north-west) and south-west external elevations

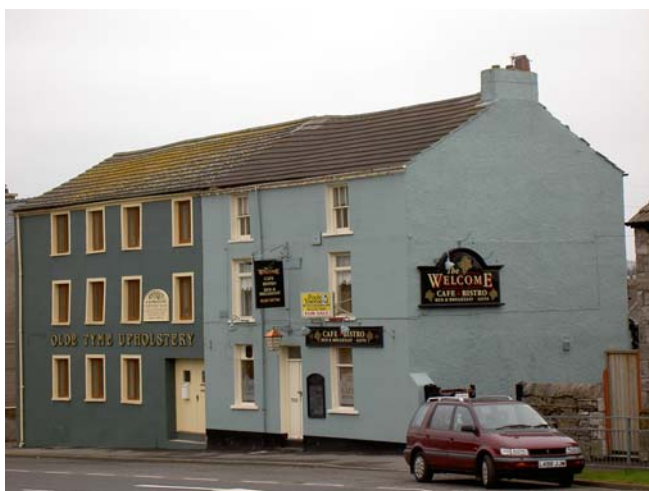
Site Number: 62**Address:** Quay Street**Current use:** Empty**Preservation:** 1**Condition:** Good**Statutory designation:** None**Architectural quality (defined by CACA):** Not examined**Description:** Large three-storey building attached to the Welcome Inn, rendered and painted, with four windows on the first and second floors of the north-west elevation. There are three further windows on the ground floor and a pedestrian doorway. No evidence for loading doorways or other warehouse features but included on account of size and lack of obvious alternative function.**Images:**

Front (north-west) external elevation

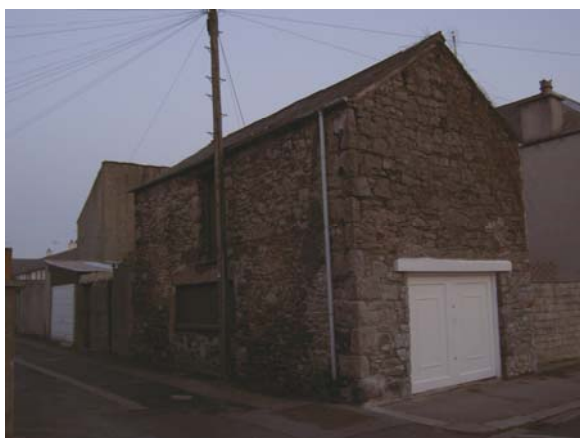
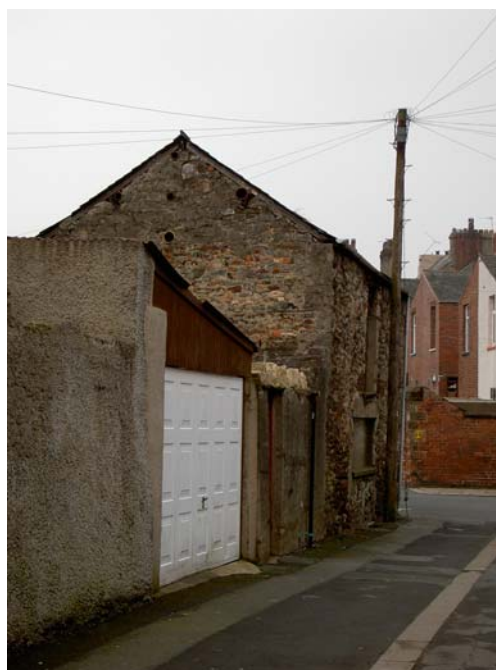
Condition: Fair

Description: Small two-storey building, with garage doorway in west elevation. It is built of a mix of brick and stone and appears to have been built onto an existing boundary wall. The north elevation has a blocked gateway through the original wall and a first floor level loading doorway. A large amount of the original wall is built from re-used foundry waste including vitrified pieces of crucible and furnace lining brick. It is within the grounds of a building named Argyll House, which has a date stone marked '1886 JD'.

North and west external elevations (left) and north and east external elevations (right)

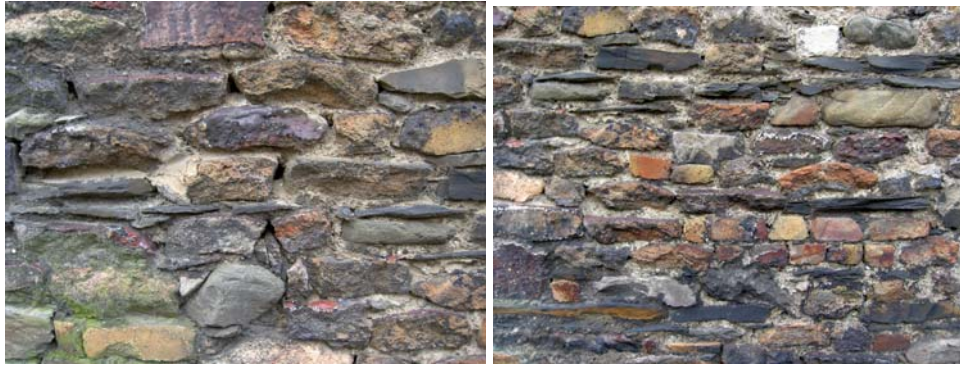
Detail of re-used foundry waste in north elevation

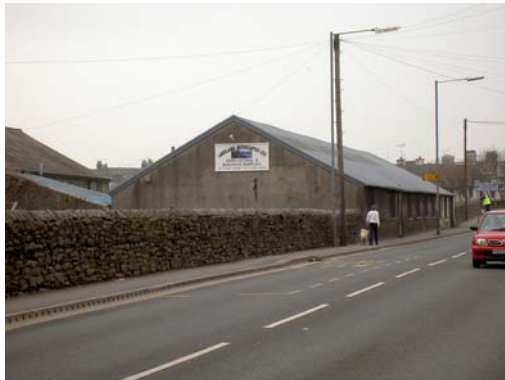
Site Number: 64

Condition: Fair

Description: Large two storey building similar to Sites **55** and **59**. Rendered, with a row of windows along the north-west elevation onto the road (probably inserted). There are large doorways and further windows in the south-east elevation and blocked first floor apertures in the north-east elevation. The north-west side is at a higher level, potentially allowing access from the road.

North-west and north-east external elevations

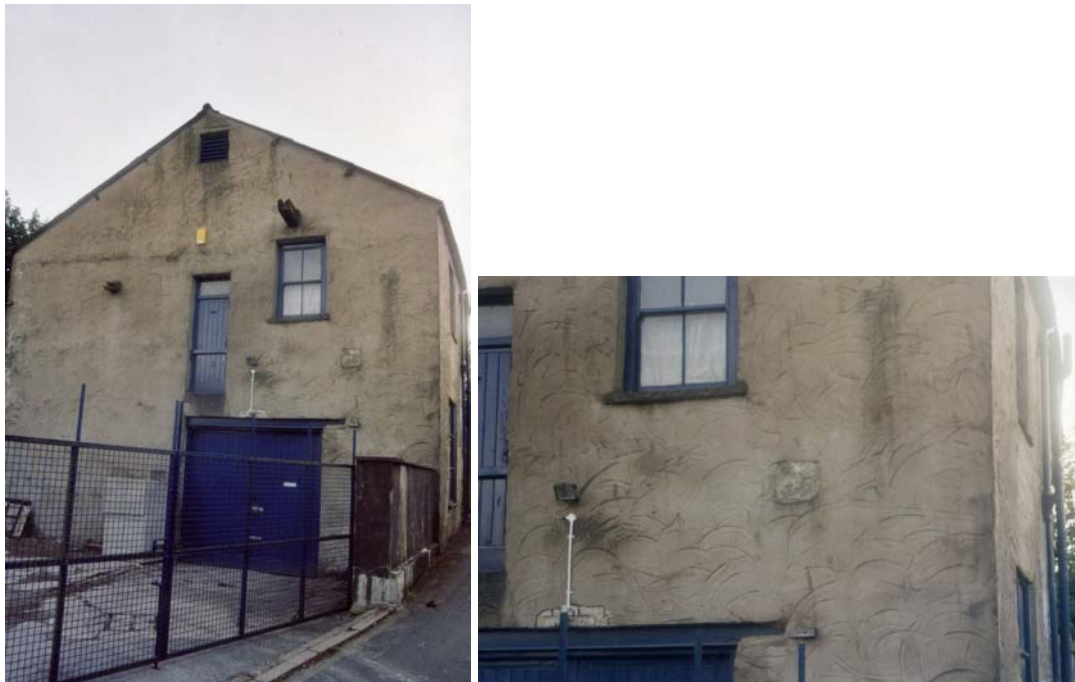
Site Number: 65

Condition: Poor

visible possibly marked '179?', although the style of the text would suggest it is earlier.

Front (south) elevation (left) and detail of date stone (right)

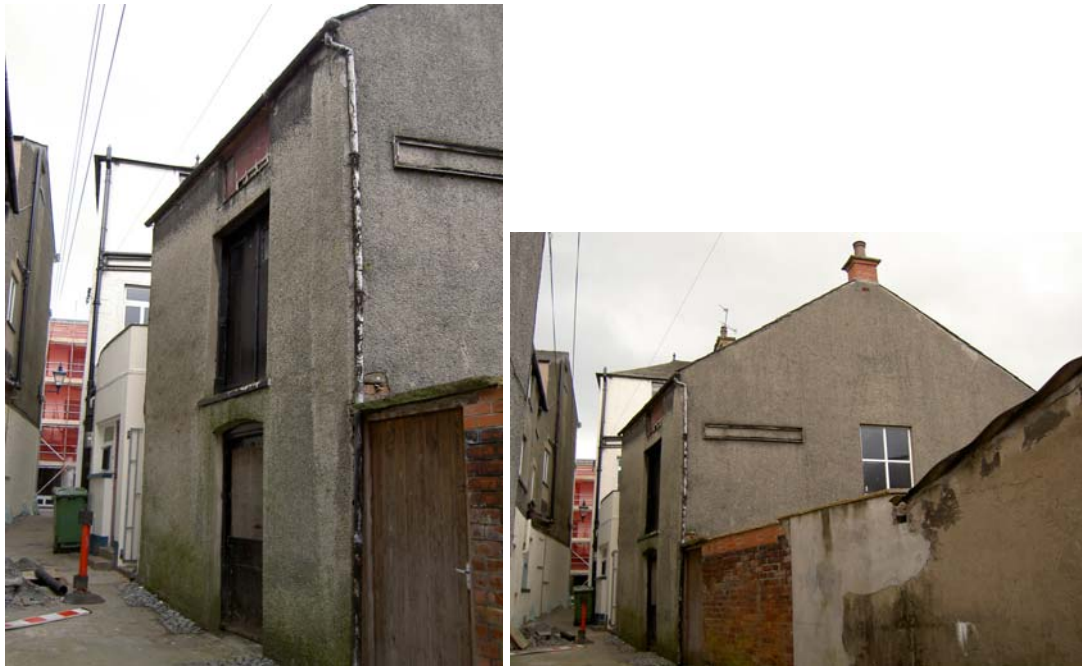
Site Number: 66

Condition: Fair

Description: Small two-storey building, rendered. The south elevation has a ground floor pedestrian doorway, a loading doorway above and a further small overlook above this (which may have been another full aperture, suggesting the building has been reduced in height). The west gable has a late chimney and a single first floor window.

South external elevation (left) and west external elevation (right)

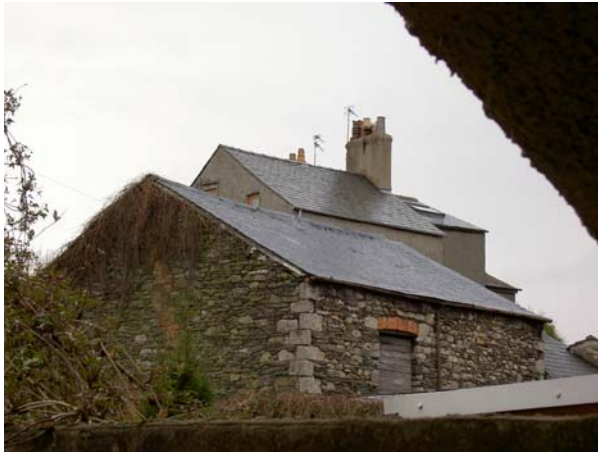
Site Number: 67

Condition: Poor

Description: Small, two storey building, randomly coursed slate construction with dressed limestone quoins and alterations in brick. The west elevation has a possible single first floor loading doorway with a flat brick arch (possibly just a window) and the north elevation has alterations in brick suggesting the position of a chimney.

North and west external elevations

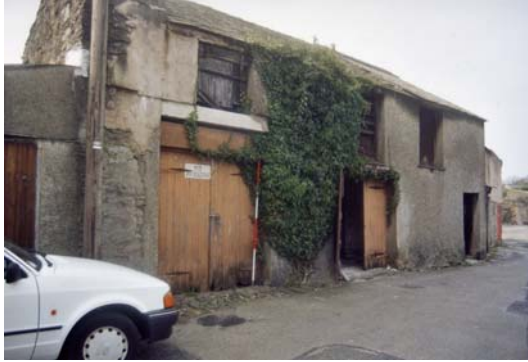
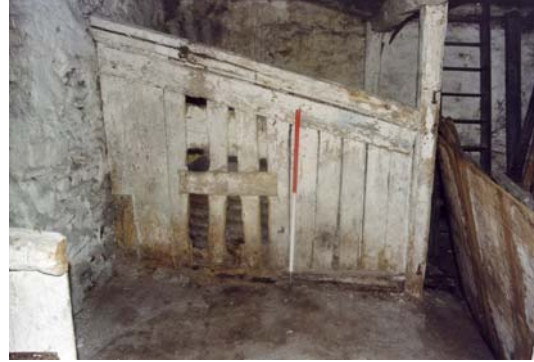
and a pedestrian doorway on the ground floor and three first floor apertures, two of which were probably loading doorways. It was originally used as a threshing barn but later became a slaughterhouse and may have been used as workshops, which may explain the addition of loading doorways.

The front (east) external elevation prior to redevelopment (left) and the remains of animal stalls in the north end (right)

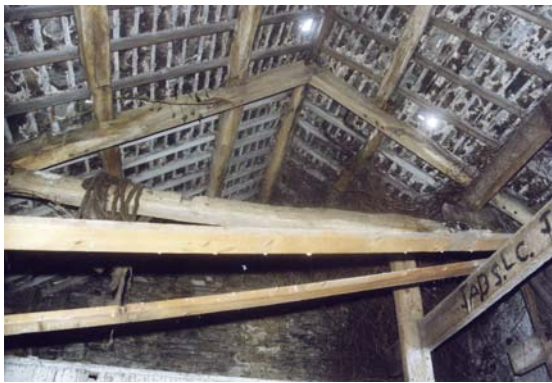
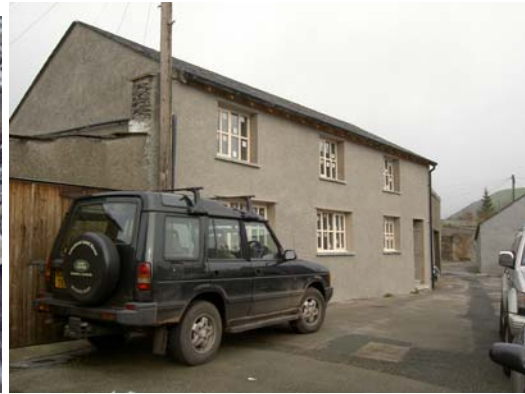
The tie beam truss within the building (left) and the front (east) external elevation after redevelopment (right)
